Access Compliance Report

Public Rights-of-Way

(Curb Ramps)

| Intersection ID: 15195 | Main Street: ALBEMARLE_RD | Cross Street: FARM_POND_LN | Location: SW |

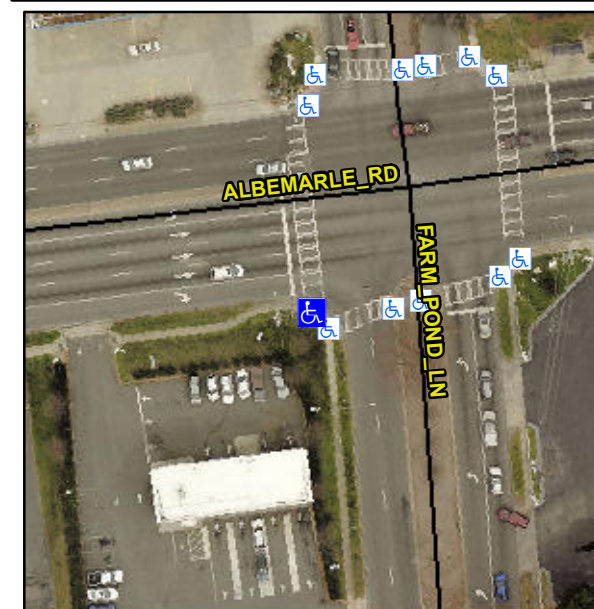
| ADA ID: 0C1673F17B1D | Ramp Type: Perp | Initial Pass/Fail: Fail | Overall Compliance: No |
| Severity Score: 8.75 | | | |

Not Found, R304.5.1

| Compliance | Description | Data | Compliance | Description | Data |
|---|---|---|---|---|---|
| No | Ramp Width (in) | 45.5 | Yes | Ramp XSlope (%) | 1.8 |

Remove & Replace Entire Ramp.

Total Cost: \$ 1850.00
