Access Compliance Report Public Rights-of-Way (Curb Ramps)

Intersection ID: 10018240 Main Street: BIRCHSTONE_LN Cross Street: N/A Location: E

ADA ID: 0C62B495DE82 Ramp Type: Perp Initial Pass/Fail: Fail Overall Compliance: No Severity Score: 8.75

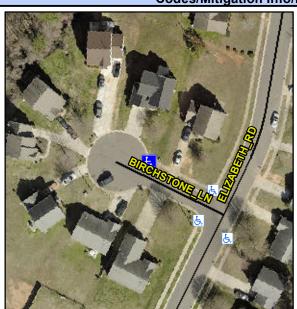
Field Measurements/Component Compliance								
Compliance Description		Data	Comp	liance Description	Data			
	N/A	Ramp Length (in)	53.0	Yes	Ramp Slope (%)	7.4		
	No	Ramp Width (in)	36.0	Yes	Ramp XSlope (%)	0.8		
	N/A	Flare Type LT	N/A	N/A	Flare Type RT	N/A		
	N/A	Flare Slope LT (%)	N/A	N/A	Flare Slope RT (%)	N/A		
	N/A	Flare Traversable LT?	N/A	N/A	Flare Traversable RT?	N/A		
	N/A	Landing Length (in)	N/A	N/A	DWS Provided?	N/A		
	N/A	Landing Width (in)	N/A	N/A	DWS Contrast?	N/A		
	N/A	Landing Slope (%)	N/A	N/A	DWS Length (in)	N/A		
	N/A	Landing X Slope (%)	N/A	N/A	DWS Full Width?	N/A		
	N/A	Landing Curb? (Y/N)	N/A	N/A	DWS Offset (in)	N/A		
	N/A	Shared Landing?	N/A					
	N/A	Gutter Ponding?	N/A	N/A	Gutter Slope (%)	N/A		
	N/A	Gutter Lip Ht (in)	0.5	N/A	Gutter X Slope (%)	N/A		
	N/A	Painted X Walk1?	No	N/A	Painted X Walk2?	N/A		
		X Walk 1 Direction	To W		X Walk 2 Direction	N/A		
	N/A	X Walk 1 Width (in)	N/A	N/A	X Walk 2 Width (in)	N/A

X Walk 1 Slope (%)	4.6		X Walk 2 Slope (%)	N/A		
		X Walk 1 X Slope (%)	2.6		X Walk 2 X Slope (%)	N/A		
	N/A	Ramp inside XWalk1?	N/A	N/A	Ramp inside XWalk2?	N/A		
		Road Slope (%)	N/A	N/A	Clear Space?	N/A		
		Road X Slope (%)	N/A	N/A	Clear Space to XWalk (in)	N/A		
	N/A	Any Obstructions?	N/A	N/A	Storm Grate/Utility Hazard?	N/A		
		Obstruction Type			Storm Grate/Utility Type			
			N/A			N/A		
				Yes	Surface Condition? (G/P)	Good

Possible Solutions:	Cor
Remove & Replace Entire Ramp.	N/A
·	No
	N/A
	N/A
	N/A
	N/A
Surveyor Notes:	N/A
N/A	N/A
	N/A
	N/A
	N/A
PROW/ADA:	N/A
Not Found, R304.5.1	N/A
	N/A
	N/A
	N/A

Total Cost:	\$	1850.00
