Access Compliance Report

Public Rights-of-Way

| Intersection ID: 6485 | Main Street: CATHEY_RD | Cross Street: FIELDING_RD | Location: | N |
| ADA ID: 0CD2D3A888DE | Ramp Type: Perp | Initial Pass/Fail: Fail | Overall Compliance: No | Severity Score: 10 |

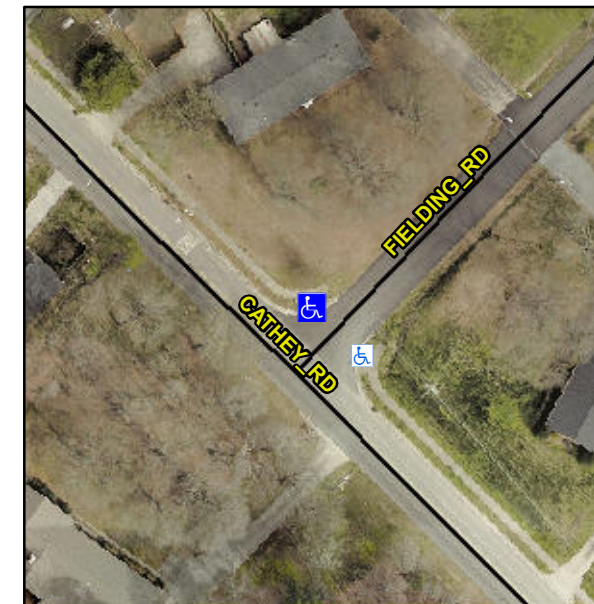
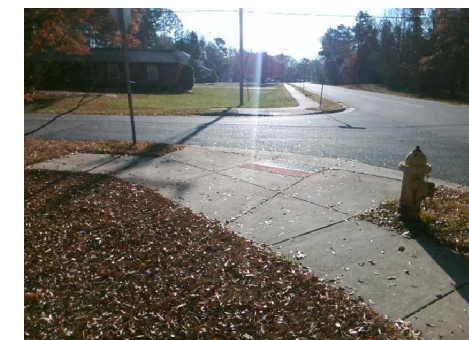
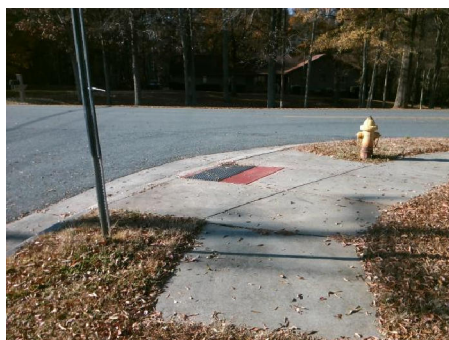
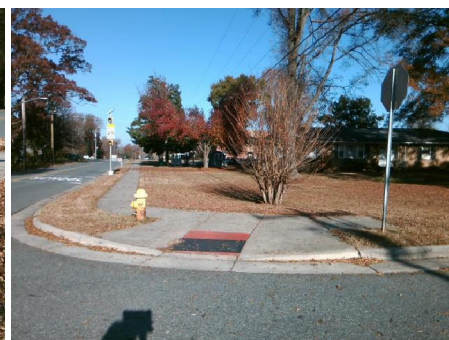
R304.5.1, R304.5.3

| Compliance | Description | Data | Compliance | Description | Data |
|---|---|---|---|---|---|
| No | Ramp Width (in) | 47.5 | No | Ramp XSlope (%) | 3.1 |

Remove & Replace Entire Ramp.
