Access Compliance Report

Public Rights-of-Way

(Curb Ramps)

Intersection ID: 54709	Main Street: MARY_BUTLER_WY	Cross Street: OLD_PROVIDENCE_RD	Location: SW
ADA ID: 0D5997DF9190	Ramp Type: Perp	Initial Pass/Fail: Fail	Overall Compliance: No
Severity Score: 13.75			
Codes/Mitigation Info/Possible Solution		Field Measurements/Component Compliance

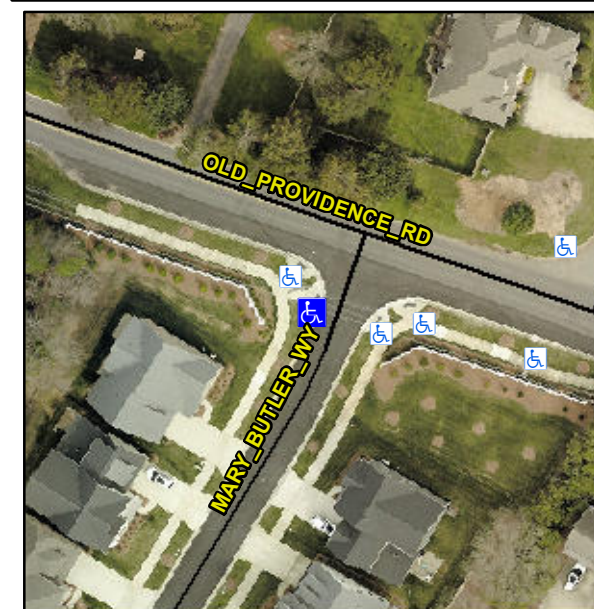
Not Found, R304.2.2, R304.5.3

Compliance	Description	Data	Compliance	Description	Data
N/A	Ramp Length (in)	95.0	No	Ramp Slope (%)	9.0
Yes	Ramp Width (in)	72.0	No	Ramp XSlope (%)	4.0
N/A	Flare Type LT	N/A	N/A	Flare Type RT	N/A
N/A	Flare Slope LT (%)	N/A	N/A	Flare Slope RT (%)	N/A
N/A	Flare Traversable LT?	N/A	N/A	Flare Traversable RT?	N/A
N/A	Landing Length (in)	N/A	N/A	DWS Provided?	N/A
N/A	Landing Width (in)	N/A	N/A	DWS Contrast?	N/A
N/A	Landing Slope (%)	N/A	N/A	DWS Length (in)	N/A
N/A	Landing X Slope (%)	N/A	N/A	DWS Full Width?	N/A
N/A	Landing Curb? (Y/N)	N/A	N/A	DWS Offset (in)	N/A
N/A	Shared Landing?	N/A			
N/A	Gutter Ponding?	N/A	N/A	Gutter Slope (%)	N/A
N/A	Gutter Lip Ht (in)	N/A	N/A	Gutter X Slope (%)	N/A
N/A	Painted X Walk1?	No	N/A	Painted X Walk2?	N/A
	X Walk 1 Direction	To SE		X Walk 2 Direction	N/A
N/A	X Walk 1 Width (in)	N/A	N/A	X Walk 2 Width (in)	N/A
	X Walk 1 Slope (%)	0.6		X Walk 2 Slope (%)	N/A
	X Walk 1 X Slope (%)	3.9		X Walk 2 X Slope (%)	N/A

Remove & Replace Entire Ramp.
