Access Compliance Report

Public Rights-of-Way

(Curb Ramps)

Intersection ID: 5093	Main Street: KELVIN_PARK_CR	Cross Street: PENNYCROSS_LN	Location: SW
ADA ID: 0D99DF2D0820	Ramp Type: Combination1	Initial Pass/Fail: Fail	Overall Compliance: No
			Severity Score: 46.25

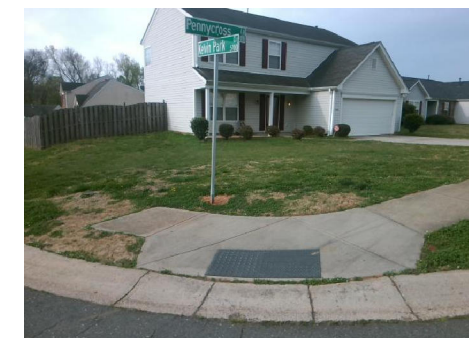
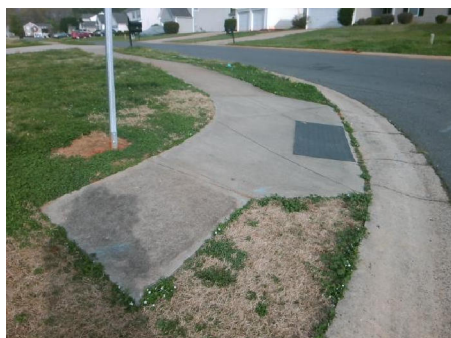
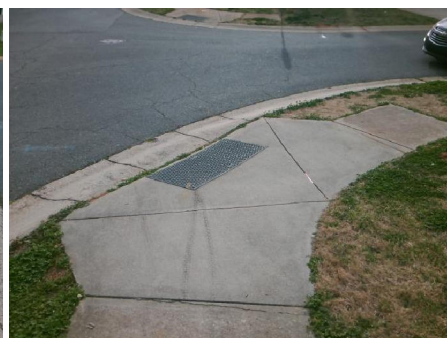
NO LT SW

**Not Found, R304.5.1, R304.5.1,
R304.2.2, R304.5.3, R304.3.2**

Compliance	Description	Data	Compliance	Description	Data
N/A	Ramp Length LT (in)	46.0	N/A	Ramp Length RT (in)	60.0
No	Ramp Width LT (in)	47.0	Yes	Ramp Width RT (in)	48.0
Yes	Ramp Slope LT (%)	5.1	No	Ramp Slope RT (%)	9.2
No	Ramp XSlope LT (%)	6.2	Yes	Ramp XSlope RT (%)	1.4
N/A	Ramp Length (in)	69.0	No	Ramp Slope (%)	10.8
No	Ramp Width (in)	37.0	No	Ramp XSlope (%)	10.7
N/A	Flare Type LT	N/A	N/A	Flare Type RT	N/A
N/A	Flare Slope LT (%)	N/A	N/A	Flare Slope RT (%)	N/A
N/A	Flare Traversable LT?	N/A	N/A	Flare Traversable RT?	N/A
N/A	Landing Length (in)	N/A	N/A	DWS Provided?	N/A
N/A	Landing Width (in)	N/A	N/A	DWS Contrast?	N/A
N/A	Landing Slope (%)	N/A	N/A	DWS Length (in)	N/A
N/A	Landing X Slope (%)	N/A	N/A	DWS Full Width?	N/A
N/A	Landing Curb? (Y/N)	N/A	N/A	DWS Offset (in)	N/A
N/A	Shared Landing?	N/A			
N/A	Gutter Ponding?	N/A	N/A	Gutter Slope (%)	N/A
N/A	Gutter Lip Ht (in)	N/A	N/A	Gutter X Slope (%)	N/A
N/A	Painted X Walk1?	No	N/A	Painted X Walk2?	N/A

X Walk 1 Direction	To E		X Walk 2 Direction	N/A
	X Walk 1 Width (in)	N/A		X Walk 2 Width (in)	N/A
	X Walk 1 Slope (%)	1.7		X Walk 2 Slope (%)	N/A
	X Walk 1 X Slope (%)	7.7		X Walk 2 X Slope (%)	N/A
N/A	Ramp inside XWalk1?	N/A	N/A	Ramp inside XWalk2?	N/A
	Road Slope (%)	N/A		Clear Space?	N/A
	Road X Slope (%)	N/A	N/A	Clear Space to XWalk (in)	N/A
			N/A	Any Obstruction?	N/A
				Obstruction Type	N/A
			N/A	Storm Grate/Utility Hazard?	N/A
				Storm Grate/Utility Type	N/A
			Yes	Surface Condition? (G/P)	Good
				Curb Slope (%)	13.0

Remove & Replace Entire Ramp.
