Access Compliance Report

Public Rights-of-Way

(Curb Ramps)

| Intersection ID: 54402 | Main Street: SPRINGMAN_LN | Cross Street: LOMA_LINDA_LN | Location: SW |

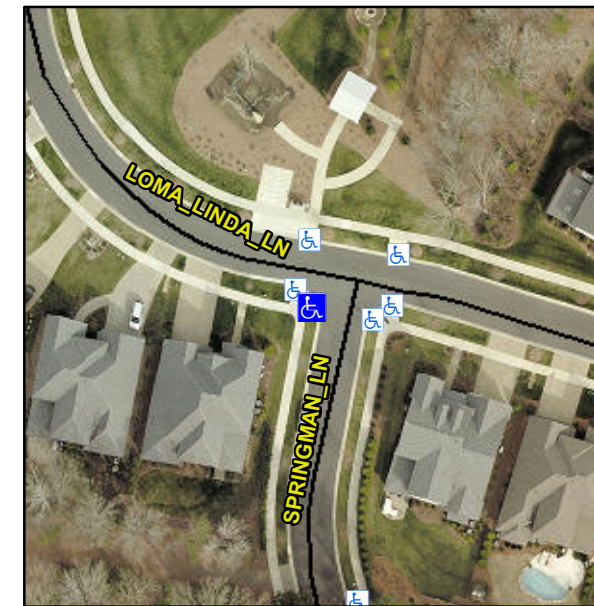
| ADA ID: 0DC168C3CD05 | Ramp Type: BlendTrans1 | Initial Pass/Fail: Fail | Overall Compliance: No |

Not Found, R304.5.1, R304.5.3

| Compliance | Description | Data | Compliance | Description | Data |
|---|---|---|---|---|---|
| No | Ramp Width (in) | 47.0 | No | BlendTrans XSlope (%) | 3.5 |

Remove & Replace Curb Ramp With Two New Directional Ramps or Equivalent.
