Access Compliance Report Public Rights-of-Way (Curb Ramps)

Intersection ID: 2776Main Street:BEAUVISTA_DRCross Street:OAK_COVE_LNLocation:SWADA ID: 0E8569ED1DBBRamp Type:PerpDiagInitial Pass/Fail:FailOverall Compliance:NoSeverity Score:10

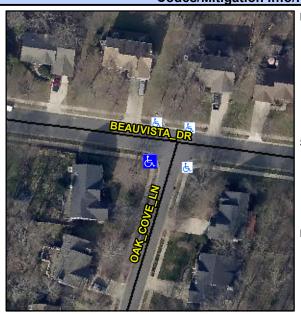
Not Found, R304.5.1, R304.5.3

r leid Measurements/Component Compnance						
	Compliance Description		Data	Compliance Description		Data
	N/A	Ramp Length (in)	46.5	Yes	Ramp Slope (%)	6.8
	No	Ramp Width (in)	40.0	No	Ramp XSlope (%)	3.4
	N/A	Flare Type LT	N/A	N/A	Flare Type RT	N/A
	N/A	Flare Slope LT (%)	N/A	N/A	Flare Slope RT (%)	N/A
	N/A	Flare Traversable LT?	N/A	N/A	Flare Traversable RT?	N/A
	N/A	Landing Length (in)	N/A	N/A	DWS Provided?	N/A
	N/A	Landing Width (in)	N/A	N/A	DWS Contrast?	N/A
	N/A	Landing Slope (%)	N/A	N/A	DWS Length (in)	N/A
	N/A	Landing X Slope (%)	N/A	N/A	DWS Full Width?	N/A
	N/A	Landing Curb? (Y/N)	N/A	N/A	DWS Offset (in)	N/A
	N/A	Shared Landing?	N/A			
	N/A	Gutter Ponding?	N/A	N/A	Gutter Slope (%)	N/A
	N/A	Gutter Lip Ht (in)	N/A	N/A	Gutter X Slope (%)	N/A
	N/A	Painted X Walk1?	No	N/A	Painted X Walk2?	No
		X Walk 1 Direction	То Е		X Walk 2 Direction	To N
	N/A	X Walk 1 Width (in)	N/A	N/A	X Walk 2 Width (in)	N/A
		X Walk 1 Slope (%)	1.4		X Walk 2 Slope (%)	1.1

X Walk 1 X Slope (%)	2.9		X Walk 2 X Slope (%)	0.6
	N/A	Ramp inside XWalk1?	N/A	N/A	Ramp inside XWalk2?	N/A
		Road Slope (%)	1.7	N/A	Clear Space?	N/A
		Road X Slope (%)	2.6	N/A	Clear Space to XWalk (in)	N/A
	N/A	Any Obstructions?	N/A	N/A	Storm Grate/Utility Hazard?	N/A
		Obstruction Type			Storm Grate/Utility Type

Remove & Replace Curb Ramp With Two New Directional Ramps or Equivalent.
