Access Compliance Report

Public Rights-of-Way

(Curb Ramps)

Intersection ID: 46315	Main Street: TYVOLA_RD	Cross Street: MARGELLINA_DR	Location: N
ADA ID: 0EA59EC90DC6	Ramp Type: ParaDiag	Initial Pass/Fail: Fail	Overall Compliance: No
			Severity Score: 26.25

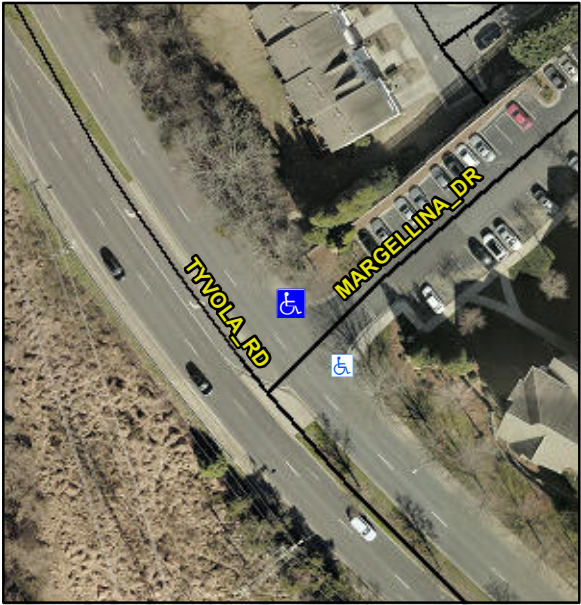
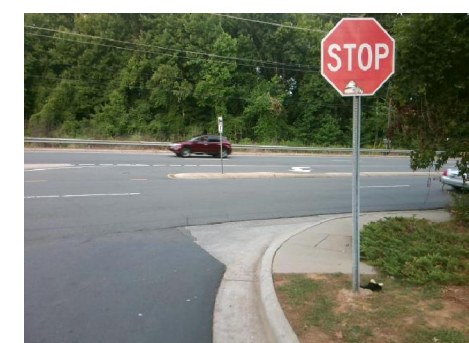
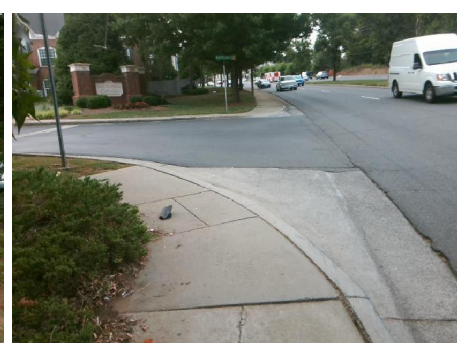
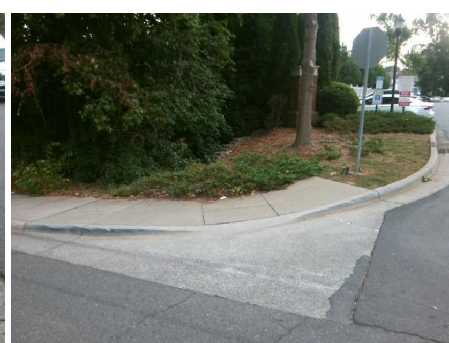
Possible Solutions:		Compliance	Description	Data
	Remove & Replace Curb Ramp With Two New Directional Ramps or Equivalent.		N/A	Ramp Length LT (in)	44.0
			Yes	Ramp Width LT (in)	59.5
			Yes	Ramp Slope LT (%)	3.7
			Yes	Ramp XSlope LT (%)	0.0
			N/A	Landing Length (in)	N/A
			N/A	Landing Width (in)	N/A
			N/A	Landing Slope (%)	N/A
			N/A	Landing X Slope (%)	N/A
			N/A	Landing Curb? (Y/N)	N/A
<p>Surveyor Notes:</p> <p>MEDIAN ACROSS TYVOLA RD, LT RP < 5%</p> <p>PROW/ADA:</p> <p>R304.3.2, R304.5.3</p>			N/A	Ramp Length RT (in)	54.0
			Yes	Ramp Width RT (in)	60.0
			No	Ramp Slope RT (%)	16.3
			No	Ramp XSlope RT (%)	2.6
			N/A	DWS Provided?	N/A
			N/A	DWS Contrast?	N/A
			N/A	DWS Length (in)	N/A
			N/A	DWS Full Width?	N/A
			N/A	DWS Offset (in)	N/A
			N/A	Gutter Slope (%)	N/A
<p>Total Cost:</p> <p>\$ 3200.00</p>			N/A	Gutter X Slope (%)	N/A

No	Painted X Walk2?	No
			To SW	X Walk 2 Direction	To SE
			N/A	X Walk 2 Width (in)	N/A
			6.5	X Walk 2 Slope (%)	3.5
			4.8	X Walk 2 X Slope (%)	2.7
			N/A	Ramp inside XWalk2?	N/A

7.4	Clear Space?	N/A
			3.1	Clear Space to XWalk (in)	N/A
			N/A	Storm Grate/Utility Hazard?	N/A
<p>Obstruction Type</p>			N/A	Storm Grate/Utility Type	N/A
			N/A	Surface Condition? (G/P)	Good
			N/A	Curb Slope (%)	15.1
