Access Compliance Report

Public Rights-of-Way

| Intersection ID: 13487 | Main Street: S_MINT_ST | Cross Street: W_KINGSTON_AV | Location: | N |
| ADA ID: 0EAE70AE28D7 | Ramp Type: Perp | Initial Pass/Fail: Fail | Overall Compliance: No | Severity Score: 10 |

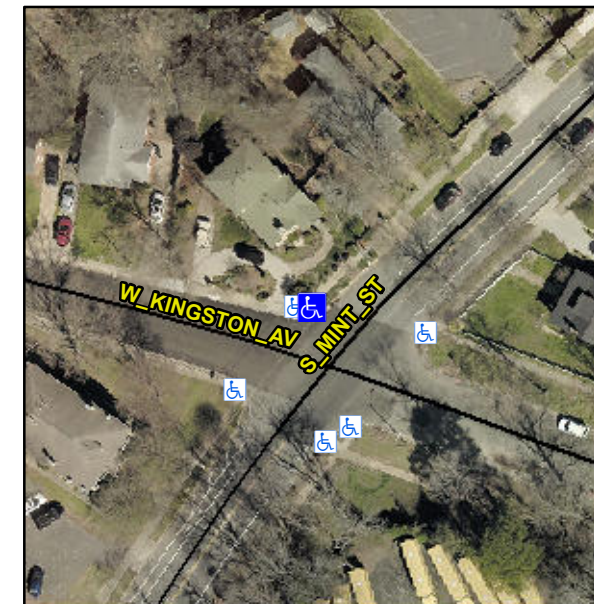
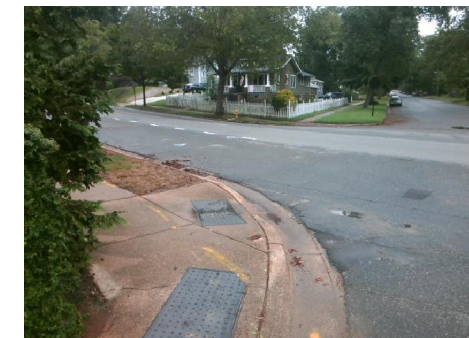
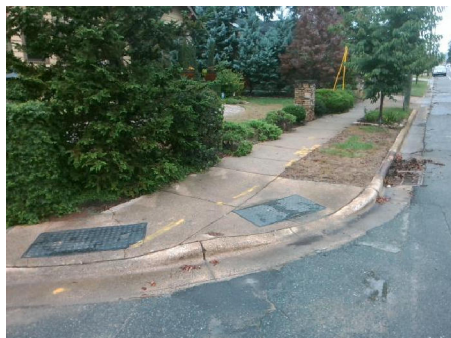
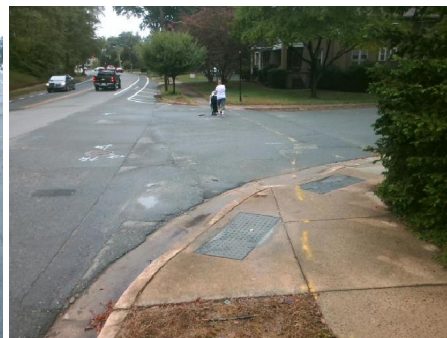
Not Found, R304.5.1, R304.5.3

| Compliance | Description | Data | Compliance | Description | Data |
|---|---|---|---|---|---|
| N/A | Ramp Length (in) | 90.0 | Yes | Ramp Slope (%) | 6.5 |
| No | Ramp Width (in) | 40.0 | No | Ramp XSlope (%) | 4.5 |

Remove & Replace Entire Ramp.
