## Access Compliance Report Public Rights-of-Way (Curb Ramps)

Intersection ID: N/A Main Street: E\_4TH\_ST Cross Street: S\_DAVIDSON\_ST Location: W

ADA ID: 0EB2AF2883D9 Ramp Type: BlendTrans1 Initial Pass/Fail: Fail Overall Compliance: No Severity Score: 33.75

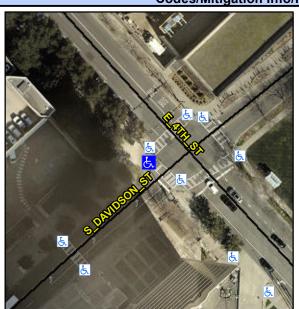
Not Found, R304.5.1, R304.5.3

Field Measurements/Component Compliance								
Compliance Description		Data	Comp	liance Description	Data			
N/A	Ramp Length (in)	64.0	Yes	BlendTrans Slope (%)	4.5			
No	Ramp Width (in)	45.0	No	BlendTrans XSlope (%)	7.0			
N/A	Flare Type LT	N/A	N/A	Flare Type RT	N/A			
N/A	Flare Slope LT (%)	N/A	N/A	Flare Slope RT (%)	N/A			
N/A	Flare Traversable LT?	No	N/A	Flare Traversable RT?	No			
N/A	Landing Length (in)	N/A	N/A	DWS Provided?	N/A			
N/A	Landing Width (in)	N/A	N/A	DWS Contrast?	N/A			
N/A	Landing Slope (%)	N/A	N/A	DWS Length (in)	N/A			
N/A	Landing X Slope (%)	N/A	N/A	DWS Full Width?	N/A			
N/A	Landing Curb? (Y/N)	N/A	N/A	DWS Offset (in)	N/A			
N/A	Shared Landing?	N/A						
N/A	Gutter Ponding?	N/A	N/A	Gutter Slope (%)	N/A			
N/A	Gutter Lip Ht (in)	N/A	N/A	Gutter X Slope (%)	N/A			
N/A	Painted X Walk1?	Yes	N/A	Painted X Walk2?	N/A			
	X Walk 1 Direction	To SE		X Walk 2 Direction	N/A			
	X Walk 1 Width (in)	107.0		X Walk 2 Width (in)	N/A

X Walk 1 Slope (%)	1.3		X Walk 2 Slope (%)	N/A			
	X Walk 1 X Slope (%)	5.1		X Walk 2 X Slope (%)	N/A			
N/A	Ramp inside XWalk1?	Yes	N/A	Ramp inside XWalk2?	N/A			
	Road Slope (%)	5.1		Clear Space?	N/A			
	Road X Slope (%)	1.3	N/A	Clear Space to XWalk (in)	N/A			
N/A	Any Obstructions?	N/A	N/A	Storm Grate/Utility Hazard?	N/A			
	Obstruction Type		l	Storm Grate/Utility Type				
		N/A	l		N/A			
			Yes	Surface Condition? (G/P)	Good			
t Por			No	Curb Slope (%)	12.8			
THE PARTY NAMED IN

Remove & Replace Curb Ramp With
Two New Directional Ramps or
Equivalent.
