## Access Compliance Report Public Rights-of-Way (Curb Ramps)

Intersection ID: 3300 Main Street: HEATHER\_VIEW\_CT Cross Street: LAKE\_SPRING\_AV Location: N

ADA ID: 0EE893147A48 Ramp Type: Perp Initial Pass/Fail: Fail Overall Compliance: No Severity Score: 1.25

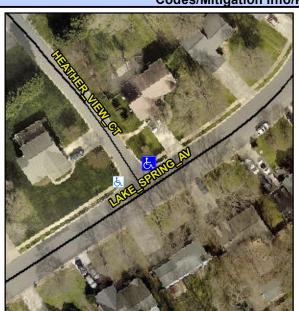
Not Found, R304.5.3

Compliance Description Data				omponent Compliance  Compliance Description Data		
N/A	Ramp Length (in)	51.0	Yes	Ramp Slope (%)	5.3	
Yes	Ramp Width (in)	48.0	No	Ramp XSlope (%)	4.9	
N/A	Flare Type LT	N/A	N/A	Flare Type RT	N/A	
N/A	Flare Slope LT (%)	N/A	N/A	Flare Slope RT (%)	N/A	
N/A	Flare Traversable LT?	N/A	N/A	Flare Traversable RT?	N/A	
N/A	Landing Length (in)	N/A	N/A	DWS Provided?	N/A	
N/A	Landing Width (in)	N/A	N/A	DWS Contrast?	N/A	
N/A	Landing Slope (%)	N/A	N/A	DWS Length (in)	N/A	
N/A	Landing X Slope (%)	N/A	N/A	DWS Full Width?	N/A	
N/A	Landing Curb? (Y/N)	N/A	N/A	DWS Offset (in)	N/A	
N/A	Shared Landing?	N/A				
N/A	Gutter Ponding?	N/A	N/A	Gutter Slope (%)	N/A	
N/A	Gutter Lip Ht (in)	N/A	N/A	Gutter X Slope (%)	N/A	
N/A	Painted X Walk1?	No	N/A	Painted X Walk2?	N/A	
	X Walk 1 Direction	To SW		X Walk 2 Direction	N/A	
N/A	X Walk 1 Width (in)	N/A	N/A	X Walk 2 Width (in)	N/A	
	X Walk 1 Slope (%)	0.3		X Walk 2 Slope (%)	N/A

X Walk 1 X Slope (%)	1.3		X Walk 2 X Slope (%)	N/A	
N/A	Ramp inside XWalk1?	N/A	N/A	Ramp inside XWalk2?	N/A	
	Road Slope (%)	N/A	N/A	Clear Space?	N/A	
	Road X Slope (%)	N/A	N/A	Clear Space to XWalk (in)	N/A	
N/A	Any Obstructions?	N/A	N/A	Storm Grate/Utility Hazard?	N/A	
	Obstruction Type			Storm Grate/Utility Type		
		N/A			N/A	
			Yes	Surface Condition? (G/P)	Good	
100

Remove & Replace Entire Ramp.
