Access Compliance Report

Public Rights-of-Way

(Curb Ramps)

Intersection ID: 50606	Main Street: DENBUR_DR	Cross Street: BENDING_BRANCH_RD	Location: E
ADA ID: 0F1C19D289B1	Ramp Type: Perp	Initial Pass/Fail: Fail	Overall Compliance: No
Severity Score: 22.5			
Codes/Mitigation Info/Possible Solution		Field Measurements/Component Compliance

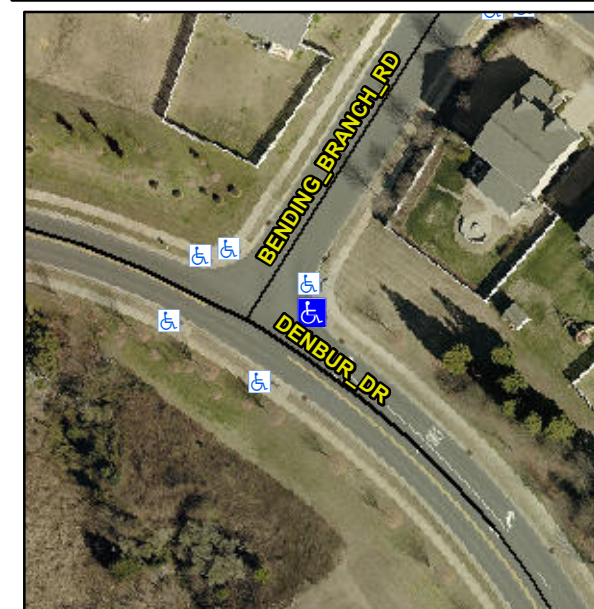
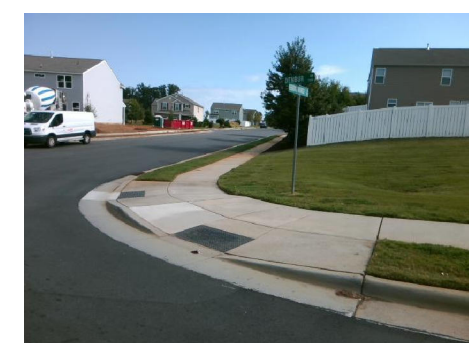
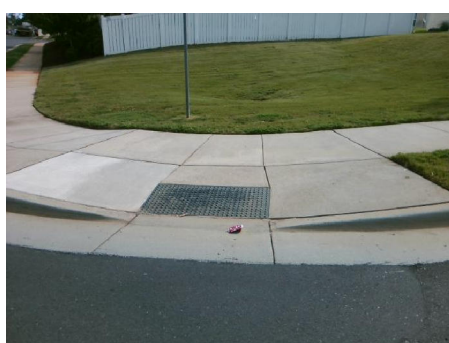
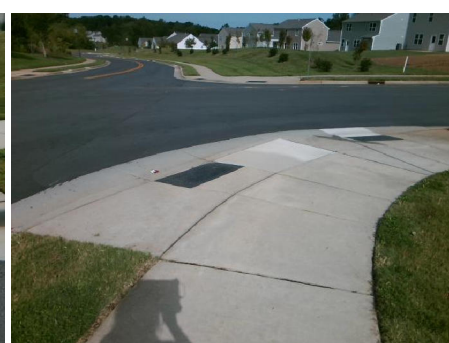
R304.5.1, R304.2.2, R304.5.3

Compliance	Description	Data	Compliance	Description	Data
N/A	Ramp Length (in)	47.0	No	Ramp Slope (%)	9.7
No	Ramp Width (in)	40.5	No	Ramp XSlope (%)	4.8
N/A	Flare Type LT	N/A	N/A	Flare Type RT	N/A
N/A	Flare Slope LT (%)	N/A	N/A	Flare Slope RT (%)	N/A
N/A	Flare Traversable LT?	N/A	N/A	Flare Traversable RT?	N/A
N/A	Landing Length (in)	N/A	N/A	DWS Provided?	N/A
N/A	Landing Width (in)	N/A	N/A	DWS Contrast?	N/A
N/A	Landing Slope (%)	N/A	N/A	DWS Length (in)	N/A
N/A	Landing X Slope (%)	N/A	N/A	DWS Full Width?	N/A
N/A	Landing Curb? (Y/N)	N/A	N/A	DWS Offset (in)	N/A
N/A	Shared Landing?	N/A			
N/A	Gutter Ponding?	N/A	N/A	Gutter Slope (%)	N/A
N/A	Gutter Lip Ht (in)	N/A	N/A	Gutter X Slope (%)	N/A
N/A	Painted X Walk1?	No	N/A	Painted X Walk2?	N/A
	X Walk 1 Direction	To SW		X Walk 2 Direction	N/A
N/A	X Walk 1 Width (in)	N/A	N/A	X Walk 2 Width (in)	N/A
	X Walk 1 Slope (%)	0.1		X Walk 2 Slope (%)	N/A
	X Walk 1 X Slope (%)	4.7		X Walk 2 X Slope (%)	N/A

Remove & Replace Entire Ramp.
