# Access Compliance Report

## Public Rights-of-Way

### (Curb Ramps)

| Intersection ID: 29658 | Main Street: PEVERELL_LN | Cross Street: TILESTON_CT | Location: | E |

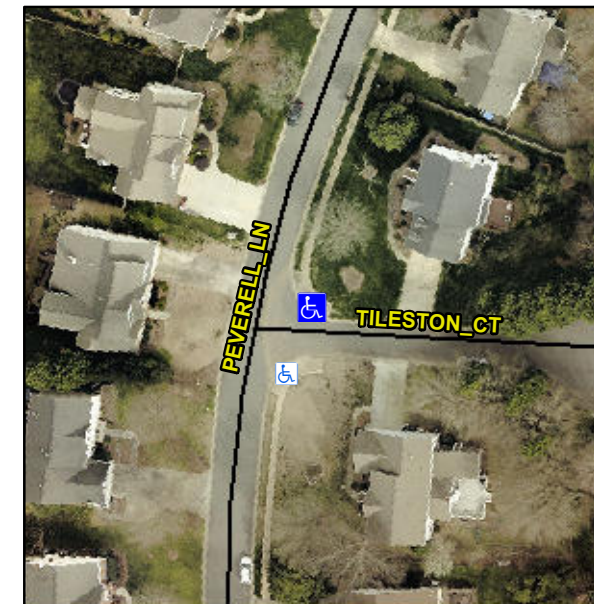
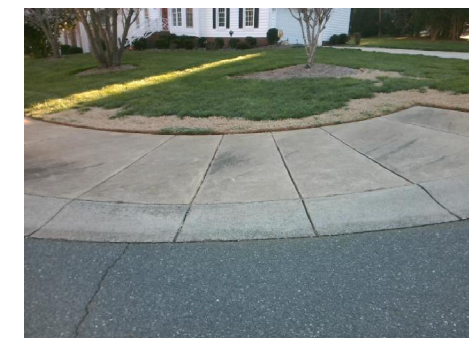
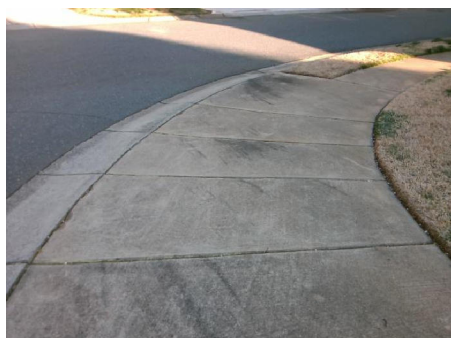
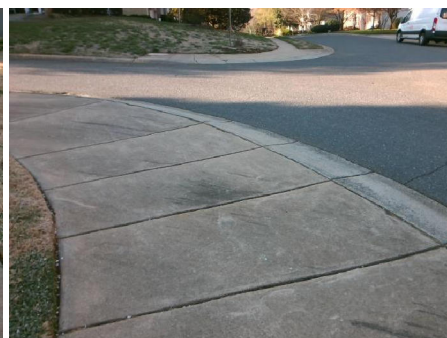
| ADA ID: 0F5DC090C1CB | Ramp Type: Perp | Initial Pass/Fail: Fail | Overall Compliance: No | Severity Score: 60 |

**Not Found, R304.5.1, R304.5.3**

| Compliance | Description | Data | Compliance | Description | Data |
|---|---|---|---|---|---|
| No | Ramp Width (in) | 30.5 | No | Ramp XSlope (%) | 10.4 |

**Remove & Replace Entire Ramp.**
