Access Compliance Report

Public Rights-of-Way

(Curb Ramps)

Intersection ID: 3925	Main Street: OAK_MANOR_LN	Cross Street: WOODFORD_BRIDGE_DR	Location: S
ADA ID: 0F672BC60895	Ramp Type: Perp	Initial Pass/Fail: Fail	Overall Compliance: No
		Severity Score: 8.75

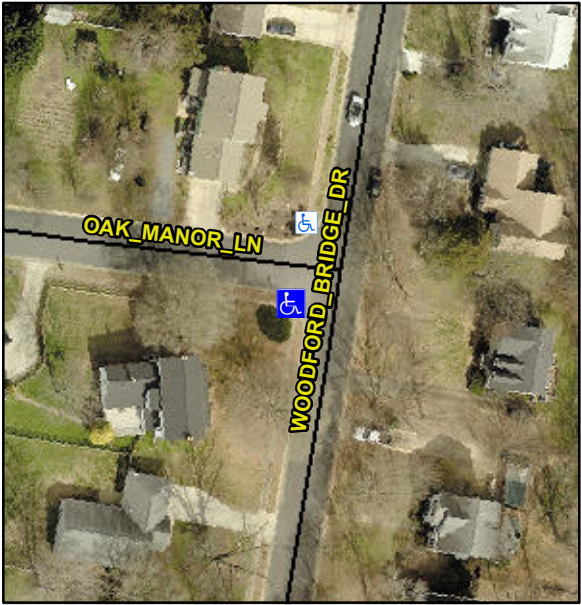
Possible Solutions:		Compliance	Description	Data
	Remove & Replace Entire Ramp.		Yes	Ramp Length (in)	90.0
			No	Ramp Width (in)	45.0
			N/A	Flare Type LT	N/A
			N/A	Flare Slope LT (%)	N/A
			N/A	Flare Traversable LT?	N/A
			N/A	Landing Length (in)	N/A
			N/A	Landing Width (in)	N/A
			N/A	Landing Slope (%)	N/A
			N/A	Landing X Slope (%)	N/A
<p>Surveyor Notes:</p> <p>N/A</p> <p>PROW/ADA:</p> <p>Not Found, R304.5.1</p>			N/A	Flare Type RT	N/A
			N/A	Flare Slope RT (%)	N/A
			N/A	Flare Traversable RT?	N/A
			N/A	DWS Provided?	N/A
			N/A	DWS Contrast?	N/A
			N/A	DWS Length (in)	N/A
			N/A	DWS Full Width?	N/A
			N/A	DWS Offset (in)	N/A
			N/A	Gutter Ponding?	N/A
			N/A	Gutter Lip Ht (in)	N/A
<p>Total Cost:</p> <p>\$ 1850.00</p>			No	Painted X Walk1?	N/A
				X Walk 1 Direction	To N
			N/A	X Walk 1 Width (in)	N/A
				X Walk 1 Slope (%)	2.8
