Access Compliance Report

Public Rights-of-Way

(Curb Ramps)

Intersection ID: 14237	Main Street: BASCOM_ST	Cross Street: LABURNUM_AV	Location:	N
ADA ID: 0F9C9238A60A	Ramp Type: BlendTrans1	Initial Pass/Fail: Fail	Overall Compliance: No	Severity Score: 12.5

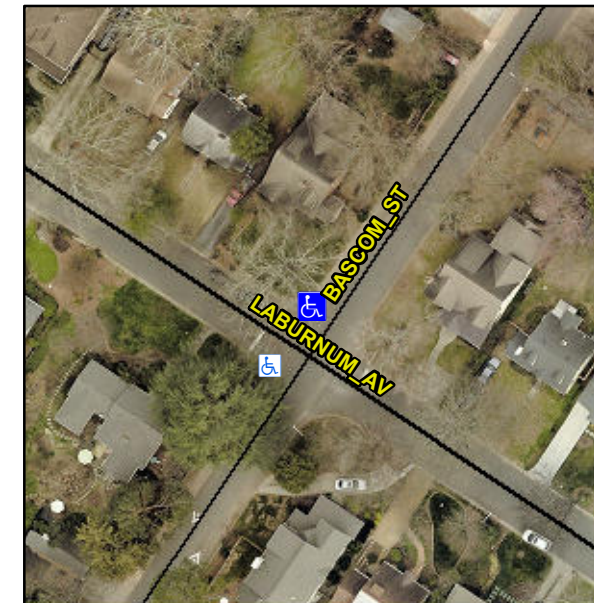
GTR GAP 9.0

Not Found, R304.5.3

Compliance	Description	Data	Compliance	Description	Data
N/A	Ramp Length (in)	61.0	Yes	BlendTrans Slope (%)	1.4
Yes	Ramp Width (in)	63.0	No	BlendTrans XSlope (%)	5.2
N/A	Flare Type LT	N/A	N/A	Flare Type RT	N/A
N/A	Flare Slope LT (%)	N/A	N/A	Flare Slope RT (%)	N/A
N/A	Flare Traversable LT?	N/A	N/A	Flare Traversable RT?	N/A
N/A	Landing Length (in)	N/A	N/A	DWS Provided?	N/A
N/A	Landing Width (in)	N/A	N/A	DWS Contrast?	N/A
N/A	Landing Slope (%)	N/A	N/A	DWS Length (in)	N/A
N/A	Landing X Slope (%)	N/A	N/A	DWS Full Width?	N/A
N/A	Landing Curb? (Y/N)	N/A	N/A	DWS Offset (in)	N/A
N/A	Shared Landing?	N/A			
N/A	Gutter Ponding?	N/A	N/A	Gutter Slope (%)	N/A
N/A	Gutter Lip Ht (in)	3.5	N/A	Gutter X Slope (%)	N/A
N/A	Painted X Walk1?	No	N/A	Painted X Walk2?	N/A
	X Walk 1 Direction	To SW		X Walk 2 Direction	N/A
	X Walk 1 Width (in)	N/A		X Walk 2 Width (in)	N/A
	X Walk 1 Slope (%)	0.9		X Walk 2 Slope (%)	N/A
	X Walk 1 X Slope (%)	2.4		X Walk 2 X Slope (%)	N/A

N/A	Ramp inside XWalk1?	N/A	N/A	Ramp inside XWalk2?	N/A
	Road Slope (%)	2.4		Clear Space?	N/A
	Road X Slope (%)	0.9	N/A	Clear Space to XWalk (in)	N/A
N/A	Any Obstructions?	N/A	N/A	Storm Grate/Utility Hazard?	N/A
	Obstruction Type			Storm Grate/Utility Type	
		N/A			N/A
			Yes	Surface Condition? (G/P)	Good
			No	Curb Slope (%)	5.8

Remove & Replace Curb Ramp With Two New Directional Ramps or Equivalent.
