Access Compliance Report Public Rights-of-Way (Curb Ramps)

Intersection ID: 2889 Main Street: ALLNESS_GLEN_LN Cross Street: HARBURN_FOREST_DR Location: N

ADA ID: 0FC4337CBEB3 Ramp Type: PerpDiag Initial Pass/Fail: Fail Overall Compliance: No Severity Score: 41.25

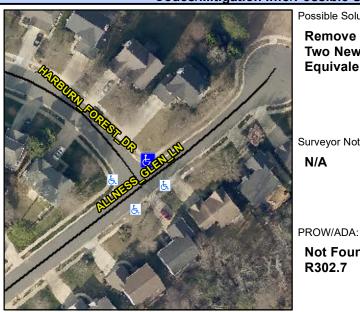
Not Found, R304.2.2, R304.5.3, R302.7

Field Measurements/Component Compilance					
Compliance Description		Data	Compliance Description		Data
N/A	Ramp Length (in)	45.5	No	Ramp Slope (%)	14.7
Yes	Ramp Width (in)	48.0	No	Ramp XSlope (%)	2.8
N/A	Flare Type LT	N/A	N/A	Flare Type RT	N/A
N/A	Flare Slope LT (%)	N/A	N/A	Flare Slope RT (%)	N/A
N/A	Flare Traversable LT?	N/A	N/A	Flare Traversable RT?	N/A
N/A	Landing Length (in)	N/A	N/A	DWS Provided?	N/A
N/A	Landing Width (in)	N/A	N/A	DWS Contrast?	N/A
N/A	Landing Slope (%)	N/A	N/A	DWS Length (in)	N/A
N/A	Landing X Slope (%)	N/A	N/A	DWS Full Width?	N/A
N/A	Landing Curb? (Y/N)	N/A	N/A	DWS Offset (in)	N/A
N/A	Shared Landing?	N/A			
N/A	Gutter Ponding?	N/A	N/A	Gutter Slope (%)	N/A
N/A	Gutter Lip Ht (in)	N/A	N/A	Gutter X Slope (%)	N/A
N/A	Painted X Walk1?	No	N/A	Painted X Walk2?	No
	X Walk 1 Direction	To SW		X Walk 2 Direction	To SE
N/A	X Walk 1 Width (in)	N/A	N/A	X Walk 2 Width (in)	N/A
	X Walk 1 Slope (%)	9.8		X Walk 2 Slope (%)	4.7

X Walk 1 X Slope (%)	1.7		X Walk 2 X Slope (%)	11.8
N/A	Ramp inside XWalk1?	N/A	N/A	Ramp inside XWalk2?	N/A
	Road Slope (%)	4.6	N/A	Clear Space?	N/A
	Road X Slope (%)	13.0	N/A	Clear Space to XWalk (in)	N/A
N/A	Any Obstructions?	N/A	N/A	Storm Grate/Utility Hazard?	N/A
	Obstruction Type			Storm Grate/Utility Type	
		N/A			N/A
			No	Surface Condition? (G/P)	Poor

Remove & Replace Curb Ramp With Two New Directional Ramps or Equivalent.
