# Access Compliance Report

## Public Rights-of-Way

### (Curb Ramps)

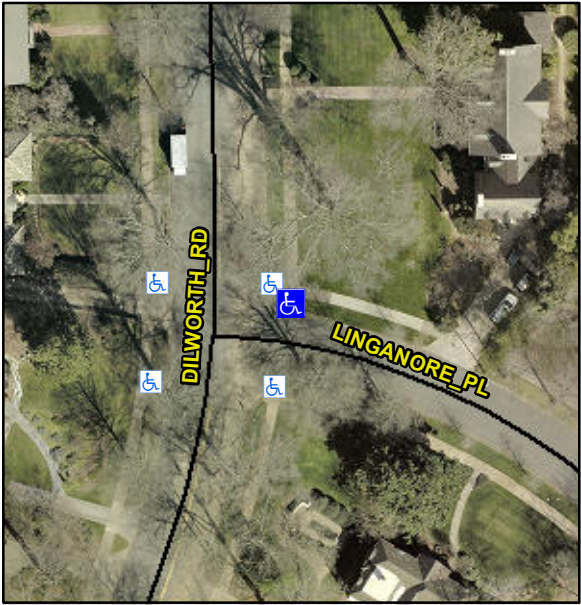
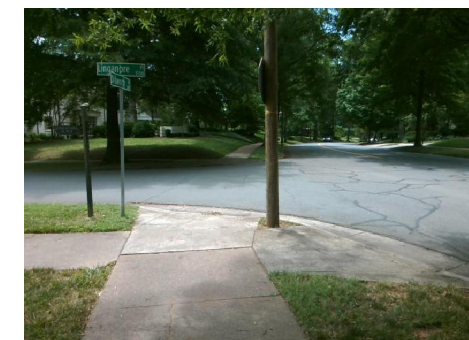
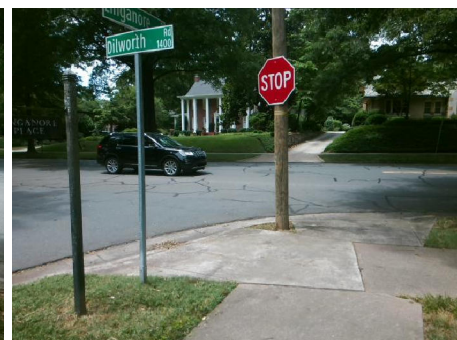
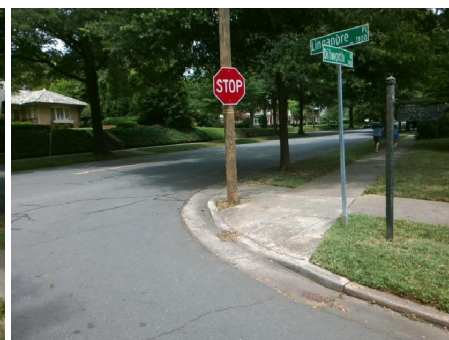
Intersection ID: 14471	Main Street: DILWORTH_RD	Cross Street: LINGANORE_PL	Location: NE
ADA ID: 0FD7278D929A	Ramp Type: Directional1	Initial Pass/Fail: Fail	Overall Compliance: No
Codes/Mitigation Info/Possible Solution		Field Measurements/Component Compliance	
Severity Score: 13.75

X Walk 1 X Slope (%)	2.4	N/A
		N/A	Ramp inside XWalk1?	N/A	N/A
		N/A	Any Obstructions?	N/A	N/A
			Obstruction Type		N/A
		Yes	Surface Condition? (G/P)	Good	Good
		N/A	Curb Slope (%)	10.3	10.3

Possible Solutions:				
	Remove & Replace Entire Ramp.				
	Surveyor Notes:				
	N/A				
	PROW/ADA:				
	R304.2.2, R304.5.3				
	Street 1 Name	LINGANORE PL			
	Stop Condition-Street 1	StopSign			
	Street 2 Name	N/A			
	Stop Condition-Street 2	N/A			
Total Cost:		\$	1600.00		
		Compliance	Description	Data	Compliance
		Description			Description
		Data			Data
		N/A	Ramp Length (in)	57.0	N/A
		Yes	Ramp Width (in)	65.0	N/A
		No	Ramp Slope (%)	9.3	N/A
		No	Ramp XSlope (%)	4.8	N/A
		N/A	Flare Type LT	N/A	N/A
		N/A	Flare Slope LT (%)	N/A	N/A
		N/A	Flare Traversable LT?	N/A	N/A
		N/A	Landing Length (in)	0.0	N/A
		N/A	Landing Width (in)	0.0	N/A
		N/A	Landing Slope (%)	0.0	N/A
		N/A	Landing X Slope (%)	0.0	N/A
		N/A	Landing Curb? (Y/N)	N/A	N/A
		N/A	Shared Landing?	N/A	N/A
		N/A	Gutter Ponding?	0.0	N/A
		N/A	Gutter Lip Ht (in)	0.0	N/A
		N/A	Painted X Walk1?	No	N/A
			X Walk 1 Direction	To S	N/A
			X Walk 1 Width (in)	N/A	N/A
			X Walk 1 Slope (%)	3.7	N/A
