Access Compliance Report Public Rights-of-Way (Curb Ramps)

Intersection ID: 54318 Main Street: CANTERBURY_CASTLE_DR Cross Street: BELMONT_MANSION_DR Location: NW **ADA ID: 0FDF0407DA31** Ramp Type: BlendTrans1 Initial Pass/Fail: Fail **Overall Compliance: No** Severity Score: 21.25

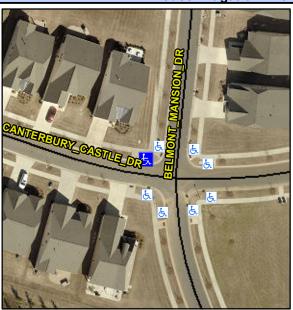
Field Measurements/Component Compliance								
Compliance Description		Data	Compliance Description		Data			
N/A	Ramp Length (in)	95.0	Yes	BlendTrans Slope (%)	1.6			
No	Ramp Width (in)	47.0	No	BlendTrans XSlope (%)	6.2			
N/A	Flare Type LT	N/A	N/A	Flare Type RT	N/A			
N/A	Flare Slope LT (%)	N/A	N/A	Flare Slope RT (%)	N/A			
N/A	Flare Traversable LT?	N/A	N/A	Flare Traversable RT?	N/A			
N/A	Landing Length (in)	N/A	N/A	DWS Provided?	N/A			
N/A	Landing Width (in)	N/A	N/A	DWS Contrast?	N/A			
N/A	Landing Slope (%)	N/A	N/A	DWS Length (in)	N/A			
N/A	Landing X Slope (%)	N/A	N/A	DWS Full Width?	N/A			
N/A	Landing Curb? (Y/N)	N/A	N/A	DWS Offset (in)	N/A			
N/A	Shared Landing?	N/A						
N/A	Gutter Ponding?	N/A	N/A	Gutter Slope (%)	N/A			
N/A	Gutter Lip Ht (in)	N/A	N/A	Gutter X Slope (%)	N/A			
N/A	Painted X Walk1?	No	N/A	Painted X Walk2?	N/A			
	X Walk 1 Direction	To S		X Walk 2 Direction	N/A			
	X Walk 1 Width (in)	N/A		X Walk 2 Width (in)	N/A

X Walk 1 Slope (%)	3.8		X Walk 2 Slope (%)	N/A			
	X Walk 1 X Slope (%)	1.1		X Walk 2 X Slope (%)	N/A			
N/A	Ramp inside XWalk1?	N/A	N/A	Ramp inside XWalk2?	N/A			
	Road Slope (%)	1.1		Clear Space?	N/A			
	Road X Slope (%)	3.8	N/A	Clear Space to XWalk (in)	N/A			
N/A	Any Obstructions?	N/A	N/A	Storm Grate/Utility Hazard?	N/A			
	Obstruction Type			Storm Grate/Utility Type				
		N/A			N/A			
			Yes	Surface Condition? (G/P)	Good			
			No	Curb Slope (%)	7.6

GGG:BIG GGIATION
Possible Solutions:
Remove & Replace Curb Ramp With Two New Directional Ramps or Equivalent.
Surveyor Notes:
N/A
PROW/ADA:
Not Found, R304.5.1, R304.5.3
