Access Compliance Report Public Rights-of-Way (Curb Ramps)

Intersection ID: 20517 Main Street: PARK_SOUTH_DR Cross Street: WOODBINE_LN Location: NW

ADA ID: 106ED09FD6CA Ramp Type: PerpDiag Initial Pass/Fail: Fail Overall Compliance: No Severity Score: 37.5

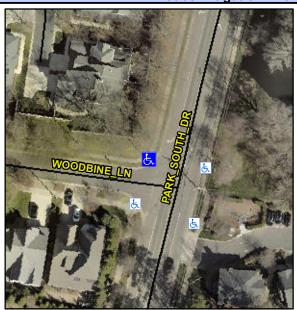
Not Found, R304.2.2, R304.5.3

Data	Compliance Description		Data
N/A	Ramp Length (in)	108.0	No	Ramp Slope (%)	10.1
Yes	Ramp Width (in)	60.0	No	Ramp XSlope (%)	12.1
N/A	Flare Type LT	N/A	N/A	Flare Type RT	N/A
N/A	Flare Slope LT (%)	N/A	N/A	Flare Slope RT (%)	N/A
N/A	Flare Traversable LT?	N/A	N/A	Flare Traversable RT?	N/A
N/A	Landing Length (in)	N/A	N/A	DWS Provided?	N/A
N/A	Landing Width (in)	N/A	N/A	DWS Contrast?	N/A
N/A	Landing Slope (%)	N/A	N/A	DWS Length (in)	N/A
N/A	Landing X Slope (%)	N/A	N/A	DWS Full Width?	N/A
N/A	Landing Curb? (Y/N)	N/A	N/A	DWS Offset (in)	N/A
N/A	Shared Landing?	N/A			
N/A	Gutter Ponding?	N/A	N/A	Gutter Slope (%)	N/A
N/A	Gutter Lip Ht (in)	N/A	N/A	Gutter X Slope (%)	N/A
N/A	Painted X Walk1?	No	N/A	Painted X Walk2?	No
	X Walk 1 Direction	To SW		X Walk 2 Direction	To SE
N/A	X Walk 1 Width (in)	N/A	N/A	X Walk 2 Width (in)	N/A
	X Walk 1 Slope (%)	8.2		X Walk 2 Slope (%)	3.0
	X Walk 1 X Slope (%)	11.1		X Walk 2 X Slope (%)	8.1

Remove & Replace Curb Ramp With Two New Directional Ramps or Equivalent.
