# Access Compliance Report

## Public Rights-of-Way

### (Curb Ramps)

| Intersection ID: 46663 | Main Street: DONATELLO_AV | Cross Street: N_DAVIDSON_ST | Location: SW |

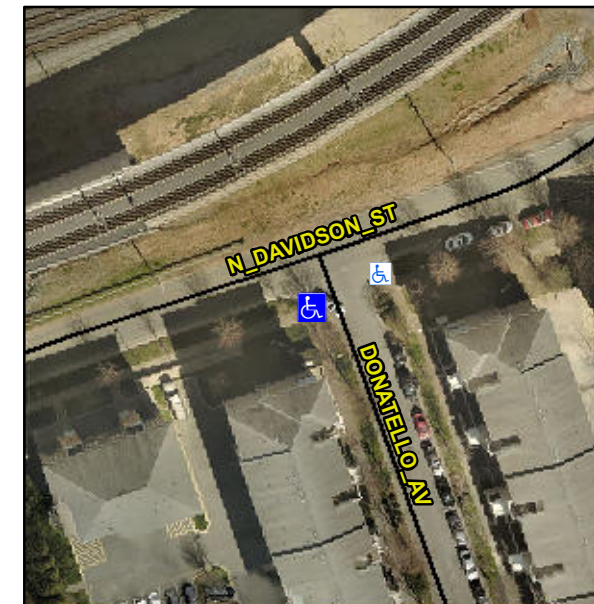
| ADA ID: 111E4D6E6ABA | Ramp Type: Perp | Initial Pass/Fail: Fail | Overall Compliance: No |

**Not Found, R304.5.1, R304.2.2, R304.5.3**

| Compliance | Description | Data | Compliance | Description | Data |
|---|---|---|---|---|---|
| N/A | Ramp Length (in) | 60.0 | No | Ramp Slope (%) | 9.9 |
| No | Ramp Width (in) | 45.0 | No | Ramp XSlope (%) | 2.3 |

**Remove & Replace Entire Ramp.**
