Access Compliance Report

Public Rights-of-Way

(Curb Ramps)

Intersection ID: 14278	Main Street: ROMARE_BEARDEN_DR	Cross Street: FARMER_ST	Location:	E
ADA ID: 114DFF430824	Ramp Type: MedianPerp	Initial Pass/Fail: Fail	Overall Compliance: No	Severity Score: 22.5
Codes/Mitigation Info/Possible Solution		Field Measurements/Component Compliance

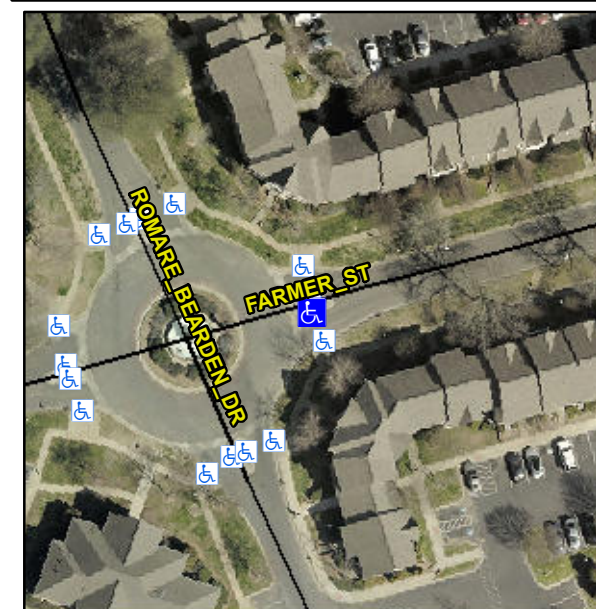
Not Found, R304.5.1, R304.2.2

Compliance	Description	Data	Compliance	Description	Data
N/A	Ramp Length (in)	40.0	No	Ramp Slope (%)	8.7
No	Ramp Width (in)	45.0	Yes	Ramp XSlope (%)	4.7
N/A	Flare Type LT	N/A	N/A	Flare Type RT	N/A
N/A	Flare Slope LT (%)	N/A	N/A	Flare Slope RT (%)	N/A
N/A	Flare Traversable LT?	N/A	N/A	Flare Traversable RT?	N/A
N/A	Landing Length (in)	N/A	N/A	DWS Provided?	N/A
N/A	Landing Width (in)	N/A	N/A	DWS Contrast?	N/A
N/A	Landing Slope (%)	N/A	N/A	DWS Length (in)	N/A
N/A	Landing X Slope (%)	N/A	N/A	DWS Full Width?	N/A
N/A	Landing Curb? (Y/N)	N/A	N/A	DWS Offset (in)	N/A
N/A	Shared Landing?	N/A			
N/A	Gutter Ponding?	N/A	N/A	Gutter Slope (%)	N/A
N/A	Gutter Lip Ht (in)	N/A	N/A	Gutter X Slope (%)	N/A
N/A	Painted X Walk1?	No	N/A	Painted X Walk2?	N/A
	X Walk 1 Direction	To S		X Walk 2 Direction	N/A
N/A	X Walk 1 Width (in)	N/A	N/A	X Walk 2 Width (in)	N/A
	X Walk 1 Slope (%)	0.7		X Walk 2 Slope (%)	N/A
	X Walk 1 X Slope (%)	4.7		X Walk 2 X Slope (%)	N/A

Remove & Replace Entire Ramp.
