Access Compliance Report

Public Rights-of-Way

(Curb Ramps)

Intersection ID: 44449	Main Street: BAYVIEW_PY	Cross Street: PRESTBURY_BV	Location: S
ADA ID: 119933ADEC99	Ramp Type: PerpDiag	Initial Pass/Fail: Fail	Overall Compliance: No
		Severity Score: 10

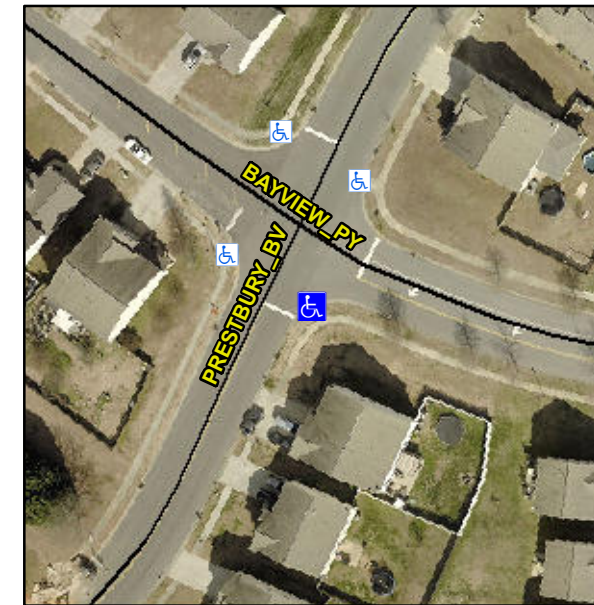
Not Found, R304.5.1, R304.5.3

Compliance	Description	Data	Compliance	Description	Data
N/A	Ramp Length (in)	75.0	Yes	Ramp Slope (%)	6.5
No	Ramp Width (in)	36.5	No	Ramp XSlope (%)	4.7
N/A	Flare Type LT	N/A	N/A	Flare Type RT	N/A
N/A	Flare Slope LT (%)	N/A	N/A	Flare Slope RT (%)	N/A
N/A	Flare Traversable LT?	N/A	N/A	Flare Traversable RT?	N/A
N/A	Landing Length (in)	N/A	N/A	DWS Provided?	N/A
N/A	Landing Width (in)	N/A	N/A	DWS Contrast?	N/A
N/A	Landing Slope (%)	N/A	N/A	DWS Length (in)	N/A
N/A	Landing X Slope (%)	N/A	N/A	DWS Full Width?	N/A
N/A	Landing Curb? (Y/N)	N/A	N/A	DWS Offset (in)	N/A
N/A	Shared Landing?	N/A			
N/A	Gutter Ponding?	N/A	N/A	Gutter Slope (%)	N/A
N/A	Gutter Lip Ht (in)	N/A	N/A	Gutter X Slope (%)	N/A
N/A	Painted X Walk1?	No	N/A	Painted X Walk2?	No
	X Walk 1 Direction	To NE		X Walk 2 Direction	To NW
N/A	X Walk 1 Width (in)	N/A	N/A	X Walk 2 Width (in)	N/A
	X Walk 1 Slope (%)	2.5		X Walk 2 Slope (%)	0.0
	X Walk 1 X Slope (%)	2.4		X Walk 2 X Slope (%)	2.8

Remove & Replace Curb Ramp With Two New Directional Ramps or Equivalent.
