Access Compliance Report

Public Rights-of-Way

(Curb Ramps)

Intersection ID: 7316	Main Street: SILCHESTER_LN	Cross Street: SWINDON_CT	Location: NE
ADA ID: 121D9DB3589B	Ramp Type: Combination2	Initial Pass/Fail: Fail	Overall Compliance: No
Severity Score: 25			
Codes/Mitigation Info/Possible Solution		Field Measurements/Component Compliance

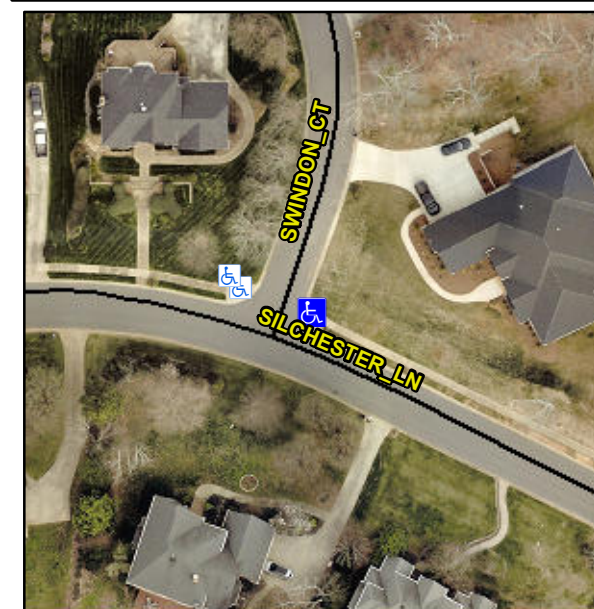
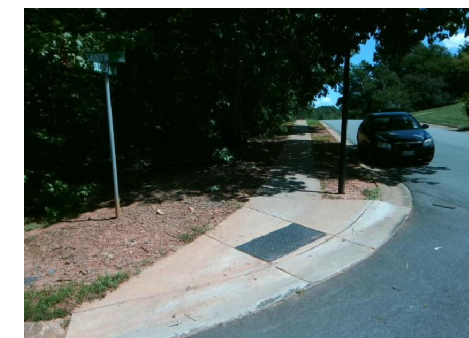
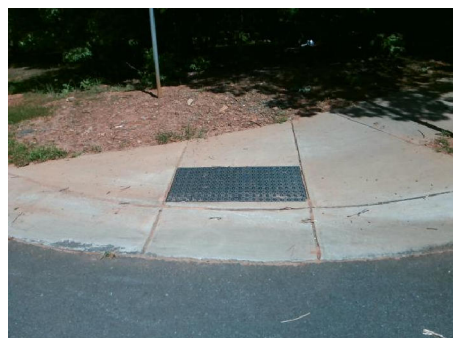
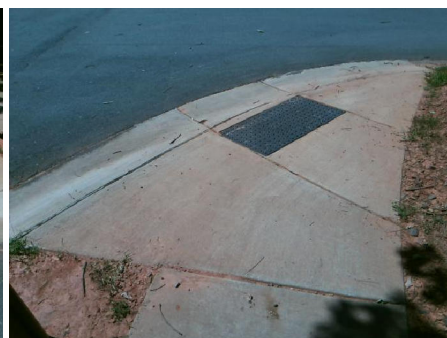
Not Found, R304.5.1, R304.5.3, R304.3.2

Compliance	Description	Data	Compliance	Description	Data
N/A	Ramp Length LT (in)	N/A	N/A	Ramp Length RT (in)	23.0
N/A	Ramp Width LT (in)	N/A	No	Ramp Width RT (in)	45.5
N/A	Ramp Slope LT (%)	N/A	No	Ramp Slope RT (%)	9.7
N/A	Ramp XSlope LT (%)	N/A	Yes	Ramp XSlope RT (%)	1.7
N/A	Ramp Length (in)	27.5	Yes	Ramp Slope (%)	5.4
Yes	Ramp Width (in)	48.0	No	Ramp XSlope (%)	5.5
N/A	Flare Type LT	N/A	N/A	Flare Type RT	N/A
N/A	Flare Slope LT (%)	N/A	N/A	Flare Slope RT (%)	N/A
N/A	Flare Traversable LT?	N/A	N/A	Flare Traversable RT?	N/A
N/A	Landing Length (in)	N/A	N/A	DWS Provided?	N/A
N/A	Landing Width (in)	N/A	N/A	DWS Contrast?	N/A
N/A	Landing Slope (%)	N/A	N/A	DWS Length (in)	N/A
N/A	Landing X Slope (%)	N/A	N/A	DWS Full Width?	N/A
N/A	Landing Curb? (Y/N)	N/A	N/A	DWS Offset (in)	N/A
N/A	Shared Landing?	N/A			
N/A	Gutter Ponding?	N/A	N/A	Gutter Slope (%)	N/A
N/A	Gutter Lip Ht (in)	N/A	N/A	Gutter X Slope (%)	N/A
N/A	Painted X Walk1?	No	N/A	Painted X Walk2?	N/A

X Walk 1 Direction	To NW		X Walk 2 Direction	N/A
	X Walk 1 Width (in)	N/A		X Walk 2 Width (in)	N/A
	X Walk 1 Slope (%)	2.7		X Walk 2 Slope (%)	N/A
	X Walk 1 X Slope (%)	4.5		X Walk 2 X Slope (%)	N/A
N/A	Ramp inside XWalk1?	N/A	N/A	Ramp inside XWalk2?	N/A
	Road Slope (%)	N/A		Clear Space?	N/A
	Road X Slope (%)	N/A	N/A	Clear Space to XWalk (in)	N/A
			N/A	Any Obstruction?	N/A
				Obstruction Type	N/A
			N/A	Storm Grate/Utility Hazard?	N/A
				Storm Grate/Utility Type	N/A
			Yes	Surface Condition? (G/P)	Good
				Curb Slope (%)	13.5

Remove & Replace Entire Ramp.
