Access Compliance Report

Public Rights-of-Way

(Curb Ramps)

Intersection ID: 52996	Main Street: TIMBERBROOK_DR	Cross Street: VICTORIA_BROOK_LN	Location: SE
ADA ID: 1255B2280D92	Ramp Type: PerpDiag	Initial Pass/Fail: Fail	Overall Compliance: No
Codes/Mitigation Info/Possible Solution		Field Measurements/Component Compliance	
Severity Score: 21.25

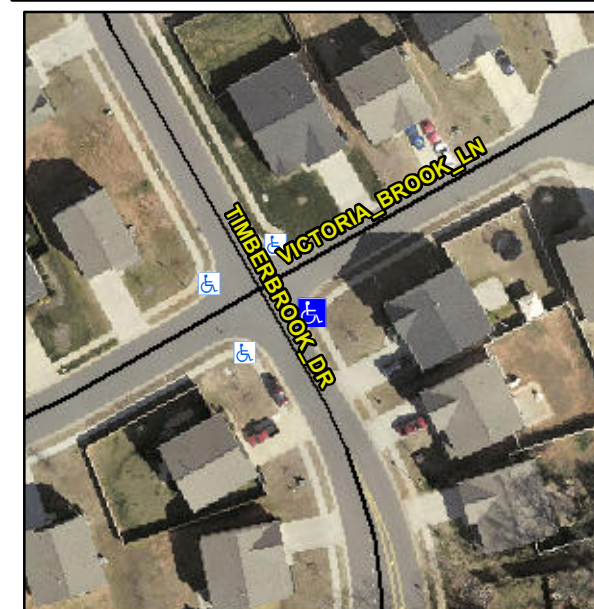
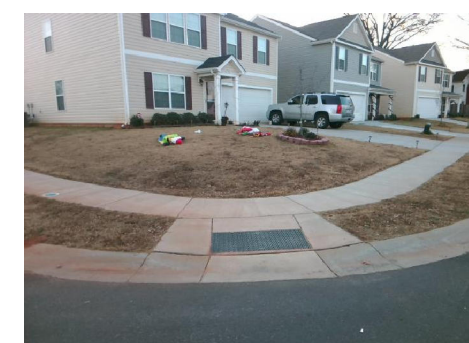
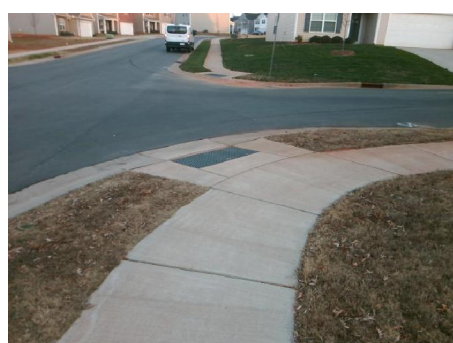
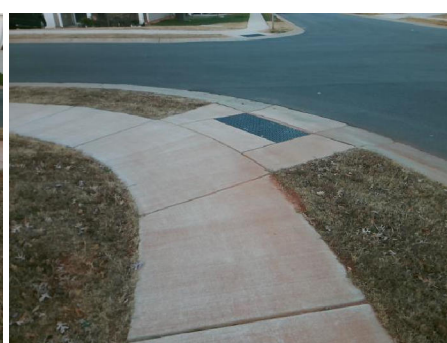
Not Found, R304.5.1, R304.2.2

Compliance	Description	Data	Compliance	Description	Data
N/A	Ramp Length (in)	48.0	No	Ramp Slope (%)	9.8
No	Ramp Width (in)	47.5	Yes	Ramp XSlope (%)	0.9
N/A	Flare Type LT	N/A	N/A	Flare Type RT	N/A
N/A	Flare Slope LT (%)	N/A	N/A	Flare Slope RT (%)	N/A
N/A	Flare Traversable LT?	N/A	N/A	Flare Traversable RT?	N/A
N/A	Landing Length (in)	N/A	N/A	DWS Provided?	N/A
N/A	Landing Width (in)	N/A	N/A	DWS Contrast?	N/A
N/A	Landing Slope (%)	N/A	N/A	DWS Length (in)	N/A
N/A	Landing X Slope (%)	N/A	N/A	DWS Full Width?	N/A
N/A	Landing Curb? (Y/N)	N/A	N/A	DWS Offset (in)	N/A
N/A	Shared Landing?	N/A			
N/A	Gutter Ponding?	N/A	N/A	Gutter Slope (%)	N/A
N/A	Gutter Lip Ht (in)	N/A	N/A	Gutter X Slope (%)	N/A
N/A	Painted X Walk1?	No	N/A	Painted X Walk2?	No
	X Walk 1 Direction	To N		X Walk 2 Direction	To W
N/A	X Walk 1 Width (in)	N/A	N/A	X Walk 2 Width (in)	N/A
	X Walk 1 Slope (%)	2.2		X Walk 2 Slope (%)	0.5
	X Walk 1 X Slope (%)	1.4		X Walk 2 X Slope (%)	2.3

N/A	Ramp inside XWalk1?	N/A	N/A	Ramp inside XWalk2?	N/A
	Road Slope (%)	0.3	N/A	Clear Space?	N/A
	Road X Slope (%)	3.6	N/A	Clear Space to XWalk (in)	N/A
N/A	Any Obstructions?	N/A	N/A	Storm Grate/Utility Hazard?	N/A
	Obstruction Type			Storm Grate/Utility Type	
		N/A			N/A
			Yes	Surface Condition? (G/P)	Good

Remove & Replace Curb Ramp With Two New Directional Ramps or Equivalent.
