Access Compliance Report Public Rights-of-Way (Curb Ramps)

Intersection ID: 51704 Main Street: IKEA_BV Cross Street: N/A Location: E

ADA ID: 1346298FE5FB Ramp Type: BlendTrans1 Initial Pass/Fail: Fail Overall Compliance: No Severity Score: 12.5

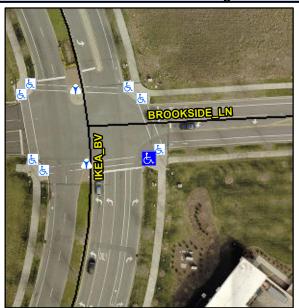
Not Found, R304.5.3

N/A	Ramp Length (in)	146.0	Yes	BlendTrans Slope (%)	3.5
Yes	Ramp Width (in)	48.0	No	BlendTrans XSlope (%)	5.9
N/A	Flare Type LT	N/A	N/A	Flare Type RT	N/A
N/A	Flare Slope LT (%)	N/A	N/A	Flare Slope RT (%)	N/A
N/A	Flare Traversable LT?	N/A	N/A	Flare Traversable RT?	N/A
N/A	Landing Length (in)	N/A	N/A	DWS Provided?	N/A
N/A	Landing Width (in)	N/A	N/A	DWS Contrast?	N/A
N/A	Landing Slope (%)	N/A	N/A	DWS Length (in)	N/A
N/A	Landing X Slope (%)	N/A	N/A	DWS Full Width?	N/A
N/A	Landing Curb? (Y/N)	N/A	N/A	DWS Offset (in)	N/A
N/A	Shared Landing?	N/A			
N/A	Gutter Ponding?	N/A	N/A	Gutter Slope (%)	N/A
N/A	Gutter Lip Ht (in)	N/A	N/A	Gutter X Slope (%)	N/A
N/A	Painted X Walk1?	Yes	N/A	Painted X Walk2?	N/A
	X Walk 1 Direction	To W		X Walk 2 Direction	N/A
	X Walk 1 Width (in)	69.0		X Walk 2 Width (in)	N/A
	X Walk 1 Slope (%)	3.1		X Walk 2 Slope (%)	N/A
	X Walk 1 X Slope (%)	1.2		X Walk 2 X Slope (%)	N/A
N/A	Ramp inside XWalk1?	Yes	N/A	Ramp inside XWalk2?	N/A

Road Slope (%)	1.2		Clear Space?	N/A
	Road X Slope (%)	3.1	N/A	Clear Space to XWalk (in)	N/A
N/A	Any Obstructions?	N/A	N/A	Storm Grate/Utility Hazard?	N/A
	Obstruction Type			Storm Grate/Utility Type	
		N/A	l		N/A
			Yes	Surface Condition? (G/P)	Good
: 0			No	Curb Slope (%)	23.0

Remove & Replace Curb Ramp With Two New Directional Ramps or Equivalent.
