Access Compliance Report

Public Rights-of-Way

(Curb Ramps)

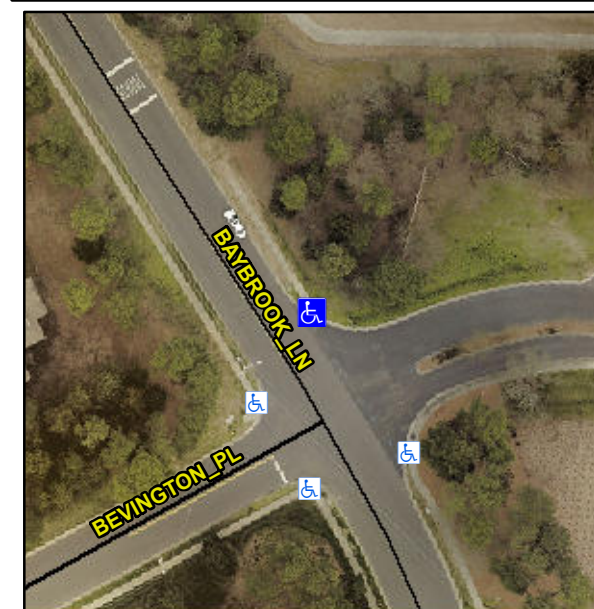
Intersection ID: 26242	Main Street: BAYBROOK_LN	Cross Street: BEVINGTON_PL	Location:	N
ADA ID: 13A831751FBD	Ramp Type: PerpDiag	Initial Pass/Fail: Fail	Overall Compliance: No	Severity Score: 37.5
Codes/Mitigation Info/Possible Solution		Field Measurements/Component Compliance

Not Found, R304.2.2, R304.5.3

Compliance	Description	Data	Compliance	Description	Data
N/A	Ramp Length (in)	32.0	No	Ramp Slope (%)	8.4
Yes	Ramp Width (in)	48.0	No	Ramp XSlope (%)	7.6
N/A	Flare Type LT	N/A	N/A	Flare Type RT	N/A
N/A	Flare Slope LT (%)	N/A	N/A	Flare Slope RT (%)	N/A
N/A	Flare Traversable LT?	N/A	N/A	Flare Traversable RT?	N/A
N/A	Landing Length (in)	N/A	N/A	DWS Provided?	N/A
N/A	Landing Width (in)	N/A	N/A	DWS Contrast?	N/A
N/A	Landing Slope (%)	N/A	N/A	DWS Length (in)	N/A
N/A	Landing X Slope (%)	N/A	N/A	DWS Full Width?	N/A
N/A	Landing Curb? (Y/N)	N/A	N/A	DWS Offset (in)	N/A
N/A	Shared Landing?	N/A			
N/A	Gutter Ponding?	N/A	N/A	Gutter Slope (%)	N/A
N/A	Gutter Lip Ht (in)	N/A	N/A	Gutter X Slope (%)	N/A
N/A	Painted X Walk1?	No	N/A	Painted X Walk2?	No
	X Walk 1 Direction	To SW		X Walk 2 Direction	To SE
N/A	X Walk 1 Width (in)	N/A	N/A	X Walk 2 Width (in)	N/A
	X Walk 1 Slope (%)	1.3		X Walk 2 Slope (%)	1.6
	X Walk 1 X Slope (%)	2.8		X Walk 2 X Slope (%)	7.1

N/A	Ramp inside XWalk1?	N/A	N/A	Ramp inside XWalk2?	N/A
	Road Slope (%)	5.7	N/A	Clear Space?	N/A
	Road X Slope (%)	4.9	N/A	Clear Space to XWalk (in)	N/A
N/A	Any Obstructions?	N/A	N/A	Storm Grate/Utility Hazard?	N/A
	Obstruction Type			Storm Grate/Utility Type	
		N/A			N/A
			Yes	Surface Condition? (G/P)	Good

Remove & Replace Curb Ramp With Two New Directional Ramps or Equivalent.
