Access Compliance Report

Public Rights-of-Way

(Curb Ramps)

Intersection ID: 28709	Main Street: FERRUM_LN	Cross Street: GREYBRIAR_FOREST_LN	Location:	N
ADA ID: 13C5B73D1230	Ramp Type: BlendTrans2	Initial Pass/Fail: Fail	Overall Compliance: No	Severity Score: 12.5
Codes/Mitigation Info/Possible Solution		Field Measurements/Component Compliance

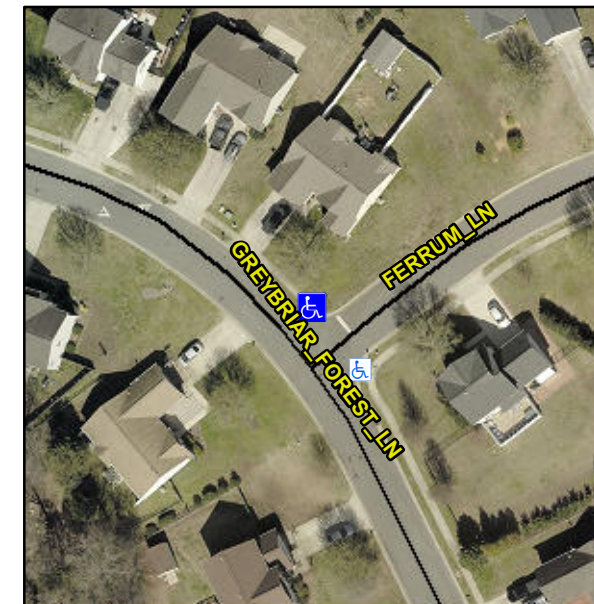
Not Found, R304.5.3

Compliance	Description	Data	Compliance	Description	Data
N/A	Ramp Length (in)	94.5	Yes	BlendTrans Slope (%)	3.3
Yes	Ramp Width (in)	48.0	No	BlendTrans XSlope (%)	5.1
N/A	Flare Type LT	N/A	N/A	Flare Type RT	N/A
N/A	Flare Slope LT (%)	N/A	N/A	Flare Slope RT (%)	N/A
N/A	Flare Traversable LT?	N/A	N/A	Flare Traversable RT?	N/A
N/A	Landing Length (in)	N/A	N/A	DWS Provided?	N/A
N/A	Landing Width (in)	N/A	N/A	DWS Contrast?	N/A
N/A	Landing Slope (%)	N/A	N/A	DWS Length (in)	N/A
N/A	Landing X Slope (%)	N/A	N/A	DWS Full Width?	N/A
N/A	Landing Curb? (Y/N)	N/A	N/A	DWS Offset (in)	N/A
N/A	Shared Landing?	N/A			
N/A	Gutter Ponding?	N/A	N/A	Gutter Slope (%)	N/A
N/A	Gutter Lip Ht (in)	N/A	N/A	Gutter X Slope (%)	N/A
N/A	Painted X Walk1?	No	N/A	Painted X Walk2?	No
	X Walk 1 Direction	To SW		X Walk 2 Direction	To SE
	X Walk 1 Width (in)	N/A		X Walk 2 Width (in)	N/A
	X Walk 1 Slope (%)	1.4		X Walk 2 Slope (%)	2.6
	X Walk 1 X Slope (%)	1.1		X Walk 2 X Slope (%)	3.3

N/A	Ramp inside XWalk1?	N/A	N/A	Ramp inside XWalk2?	N/A
	Road Slope (%)	3.5		Clear Space?	N/A
	Road X Slope (%)	5.1	N/A	Clear Space to XWalk (in)	N/A
N/A	Any Obstructions?	N/A	N/A	Storm Grate/Utility Hazard?	N/A
	Obstruction Type			Storm Grate/Utility Type	
		N/A			N/A
			Yes	Surface Condition? (G/P)	Good
			No	Curb Slope (%)	13.8

Remove & Replace Curb Ramp With Two New Directional Ramps or Equivalent.
