Access Compliance Report

Public Rights-of-Way

(Curb Ramps)

Intersection ID: 9728	Main Street: CATALINA_AV	Cross Street: FRANKLIN_AV	Location:	W
ADA ID: 144E5A29838A	Ramp Type: Combination1	Initial Pass/Fail: Fail	Overall Compliance: No	Severity Score: 37.5

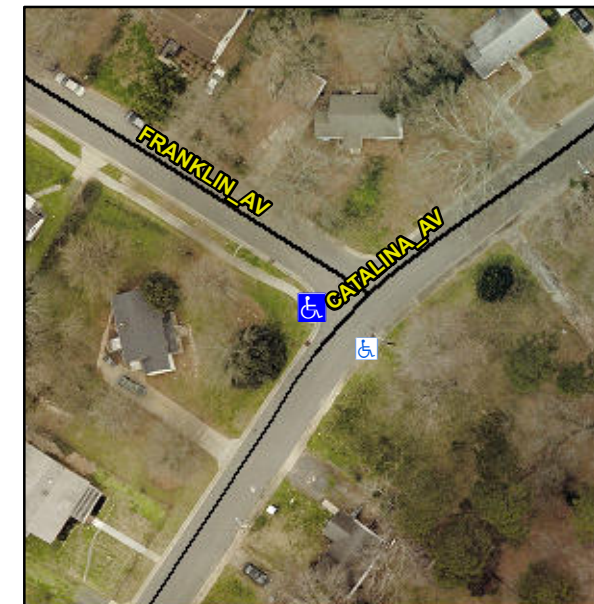
Not Found, R304.5.3, R304.3.2

Compliance	Description	Data	Compliance	Description	Data
N/A	Ramp Length LT (in)	32.5	N/A	Ramp Length RT (in)	35.0
Yes	Ramp Width LT (in)	61.5	Yes	Ramp Width RT (in)	60.0
No	Ramp Slope LT (%)	10.0	No	Ramp Slope RT (%)	10.0
Yes	Ramp XSlope LT (%)	0.1	Yes	Ramp XSlope RT (%)	0.6
N/A	Ramp Length (in)	35.0	Yes	Ramp Slope (%)	7.9
Yes	Ramp Width (in)	48.0	No	Ramp XSlope (%)	7.5
N/A	Flare Type LT	N/A	N/A	Flare Type RT	N/A
N/A	Flare Slope LT (%)	N/A	N/A	Flare Slope RT (%)	N/A
N/A	Flare Traversable LT?	N/A	N/A	Flare Traversable RT?	N/A
N/A	Landing Length (in)	N/A	N/A	DWS Provided?	N/A
N/A	Landing Width (in)	N/A	N/A	DWS Contrast?	N/A
N/A	Landing Slope (%)	N/A	N/A	DWS Length (in)	N/A
N/A	Landing X Slope (%)	N/A	N/A	DWS Full Width?	N/A
N/A	Landing Curb? (Y/N)	N/A	N/A	DWS Offset (in)	N/A
N/A	Shared Landing?	N/A			
N/A	Gutter Ponding?	N/A	N/A	Gutter Slope (%)	N/A
N/A	Gutter Lip Ht (in)	N/A	N/A	Gutter X Slope (%)	N/A
N/A	Painted X Walk1?	No	N/A	Painted X Walk2?	N/A

X Walk 1 Direction	To SE		X Walk 2 Direction	N/A
	X Walk 1 Width (in)	N/A		X Walk 2 Width (in)	N/A
	X Walk 1 Slope (%)	4.1		X Walk 2 Slope (%)	N/A
	X Walk 1 X Slope (%)	9.2		X Walk 2 X Slope (%)	N/A
N/A	Ramp inside XWalk1?	N/A	N/A	Ramp inside XWalk2?	N/A
	Road Slope (%)	N/A		Clear Space?	N/A
	Road X Slope (%)	N/A	N/A	Clear Space to XWalk (in)	N/A
			N/A	Any Obstruction?	N/A
				Obstruction Type	N/A
			N/A	Storm Grate/Utility Hazard?	N/A
				Storm Grate/Utility Type	N/A
			Yes	Surface Condition? (G/P)	Good
				Curb Slope (%)	15.9

Remove & Replace Entire Ramp.
