# Access Compliance Report

## Public Rights-of-Way

### (Curb Ramps)

Intersection ID: 50315	Main Street: PORTOLA_CT	Cross Street: ESMERALDA_DR	Location: NE
ADA ID: 15161C7BB8BF	Ramp Type: Perp	Initial Pass/Fail: Fail	Overall Compliance: No
			Severity Score: 21.25

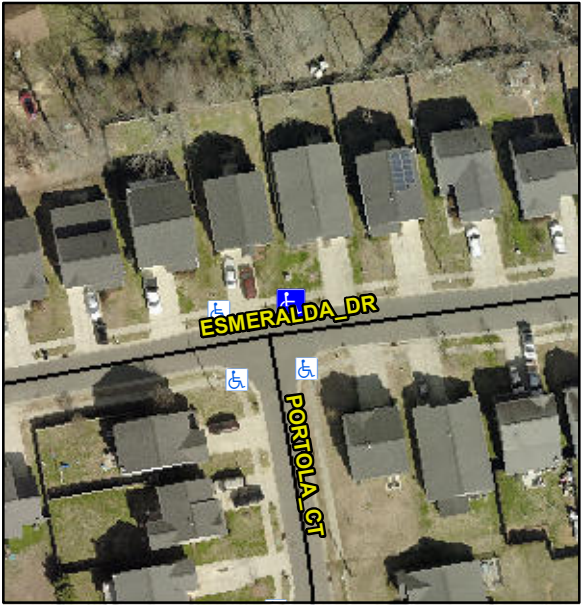
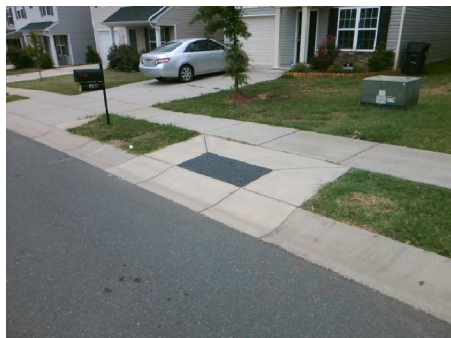
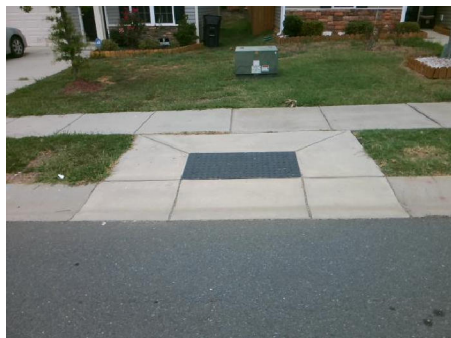
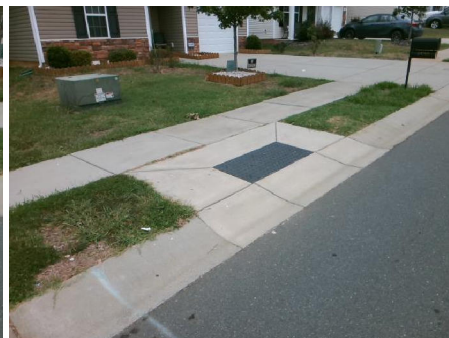
Compliance	Description	Data	Compliance	Description	Data
N/A	Ramp Length (in)	47.5	No	Ramp Slope (%)	9.5
No	Ramp Width (in)	47.0	Yes	Ramp XSlope (%)	1.7
N/A	Flare Type LT	N/A	N/A	Flare Type RT	N/A
N/A	Flare Slope LT (%)	N/A	N/A	Flare Slope RT (%)	N/A
N/A	Flare Traversable LT?	N/A	N/A	Flare Traversable RT?	N/A
N/A	Landing Length (in)	N/A	N/A	DWS Provided?	N/A
N/A	Landing Width (in)	N/A	N/A	DWS Contrast?	N/A
N/A	Landing Slope (%)	N/A	N/A	DWS Length (in)	N/A
N/A	Landing X Slope (%)	N/A	N/A	DWS Full Width?	N/A
N/A	Landing Curb? (Y/N)	N/A	N/A	DWS Offset (in)	N/A
N/A	Shared Landing?	N/A			
N/A	Gutter Ponding?	N/A	N/A	Gutter Slope (%)	N/A
N/A	Gutter Lip Ht (in)	N/A	N/A	Gutter X Slope (%)	N/A
N/A	Painted X Walk1?	No	N/A	Painted X Walk2?	N/A
	X Walk 1 Direction	To S		X Walk 2 Direction	N/A
N/A	X Walk 1 Width (in)	N/A	N/A	X Walk 2 Width (in)	N/A
	X Walk 1 Slope (%)	3.4		X Walk 2 Slope (%)	N/A
	X Walk 1 X Slope (%)	3.2		X Walk 2 X Slope (%)	N/A

N/A	Ramp inside XWalk1?	N/A	N/A	Ramp inside XWalk2?	N/A
	Road Slope (%)	N/A	N/A	Clear Space?	N/A
	Road X Slope (%)	N/A	N/A	Clear Space to XWalk (in)	N/A
N/A	Any Obstructions?	N/A	N/A	Storm Grate/Utility Hazard?	N/A
	Obstruction Type			Storm Grate/Utility Type	
		N/A			N/A
			Yes	Surface Condition? (G/P)	Good

Possible Solutions:				
	Remove & Replace Entire Ramp.				
	Surveyor Notes:				
	N/A				
	PROW/ADA:				
	Not Found, R304.5.1, R304.2.2				
Street 1 Name	ESMERALDA DR				
Stop Condition-Street 2	None				
Street 2 Name	N/A				
Stop Condition-Street 1	N/A				
Total Cost:		\$	1850.00
