## **Access Compliance Report Public Rights-of-Way** (Curb Ramps)

ADA ID: 1545ECD0F6C1 Ramp Type: PerpDiag Initial Pass/Fail: Fail **Overall Compliance: No Severity Score:** 12.5

treet 1 Name	E MARTIN LUTHER KING JR BV
top Condition-Street 2	Signal
treet 2 Name	S COLLEGE ST
top Condition-Street 1	Signal

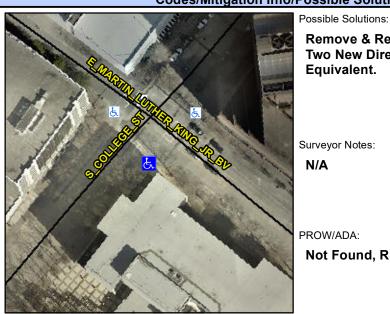
Not Found, R304.2.2

Compliance Description Data		Data	Comp	liance Description	Data
N/A	Ramp Length (in)	44.0	No	Ramp Slope (%)	8.5
Yes	Ramp Width (in)	48.0	Yes	Ramp XSlope (%)	1.1
N/A	Flare Type LT	N/A	N/A	Flare Type RT	N/A
N/A	Flare Slope LT (%)	N/A	N/A	Flare Slope RT (%)	N/A
N/A	Flare Traversable LT?	No	N/A	Flare Traversable RT?	No
N/A	Landing Length (in)	N/A	N/A	DWS Provided?	N/A
N/A	Landing Width (in)	N/A	N/A	DWS Contrast?	N/A
N/A	Landing Slope (%)	N/A	N/A	DWS Length (in)	N/A
N/A	Landing X Slope (%)	N/A	N/A	DWS Full Width?	N/A
N/A	Landing Curb? (Y/N)	N/A	N/A	DWS Offset (in)	N/A
N/A	Shared Landing?	N/A			
N/A	Gutter Ponding?	N/A	N/A	Gutter Slope (%)	N/A
N/A	Gutter Lip Ht (in)	N/A	N/A	Gutter X Slope (%)	N/A
N/A	Painted X Walk1?	Yes	N/A	Painted X Walk2?	Yes
	X Walk 1 Direction	To NE		X Walk 2 Direction	To NW
N/A	X Walk 1 Width (in)	113.0	N/A	X Walk 2 Width (in)	112.0
	X Walk 1 Slope (%)	6.4		X Walk 2 Slope (%)	3.8
	X Walk 1 X Slope (%)	3.4		X Walk 2 X Slope (%)	5.2

Remove & Replace Curb Ramp With Two New Directional Ramps or Equivalent.
