Access Compliance Report Public Rights-of-Way (Curb Ramps)

Intersection ID: 10020375 Main Street: BALLANTYNE_CORPORATE_PCross Street: N/A Location: NW

ADA ID: 159616721D15 Ramp Type: BlendTrans2 Initial Pass/Fail: Fail Overall Compliance: No Severity Score: 1.25

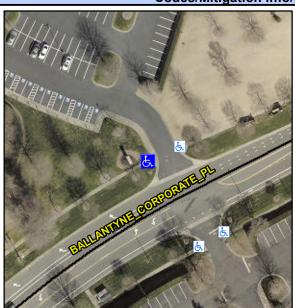
| Compliance Description Data Compliance | |
|--|---|
| Yes Ramp Width (in) 48.0 No Ble | ndTrans XSlope (%) 4.9 |

Remove & Replace Curb Ramp With Two New Directional Ramps or Equivalent.

R304.5.3
