# Access Compliance Report

## Public Rights-of-Way

### (Curb Ramps)

| Intersection ID: 10021763 | Main Street: BRICK_CHURCH_CT | Cross Street: N/A | Location: NW |

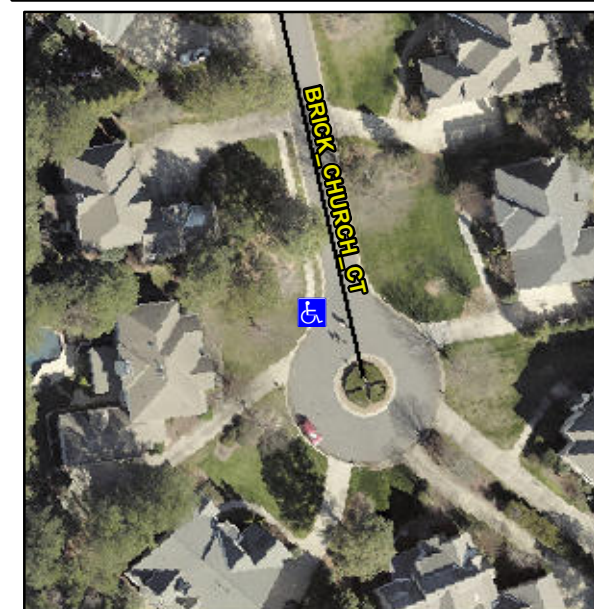
| ADA ID: 15DA81783712 | Ramp Type: Perp | Initial Pass/Fail: Fail | Overall Compliance: No |
| Severity Score: 33.75 | | | |

**R304.5.1, R304.2.2, R304.5.3**

| Compliance | Description | Data | Compliance | Description | Data |
|---|---|---|---|---|---|
| N/A | Ramp Length (in) | 89.0 | No | Ramp Slope (%) | 8.9 |
| No | Ramp Width (in) | 41.0 | No | Ramp XSlope (%) | 5.4 |

**Remove & Replace Entire Ramp.**
