# Access Compliance Report

## Public Rights-of-Way

| Intersection ID: 12909 | Main Street: FULTON_AV | Cross Street: RANDALL_ST | Location: NW |
| ADA ID: 162E687FF16C | Ramp Type: Perp | Initial Pass/Fail: Fail | Overall Compliance: No |

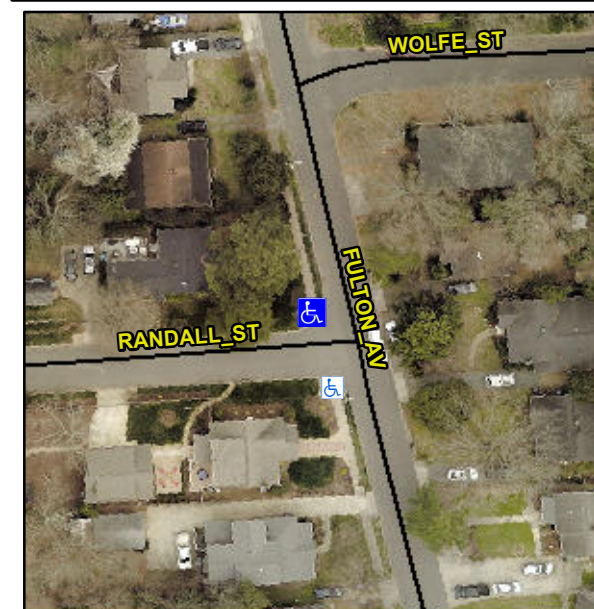
| Severity Score: 46.25 | | | |

| Compliance | Description | Data | Compliance | Description | Data |
|---|---|---|---|---|---|
| N/A | Ramp Length (in) | 48.0 | No | Ramp Slope (%) | 9.0 |
| No | Ramp Width (in) | 37.0 | No | Ramp XSlope (%) | 7.3 |

**Remove & Replace Entire Ramp.**
