# Access Compliance Report

## Public Rights-of-Way

### (Curb Ramps)

Intersection ID: 31714	Main Street: BLUE_ASH_LN	Cross Street: DEODORA_CEDAR_LN	Location: NE
ADA ID: 163BF8AC563D	Ramp Type: PerpDiag	Initial Pass/Fail: Fail	Overall Compliance: No
			Severity Score: 18.75

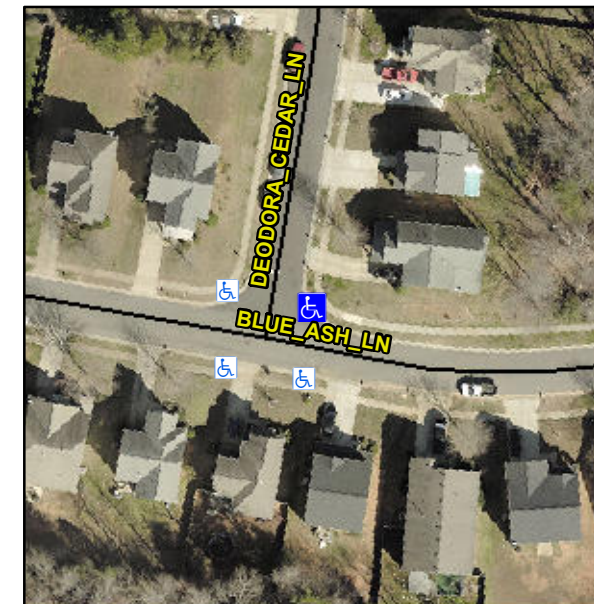
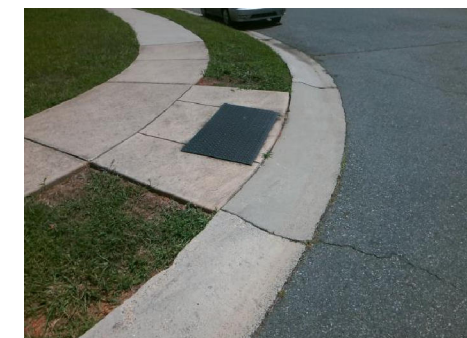
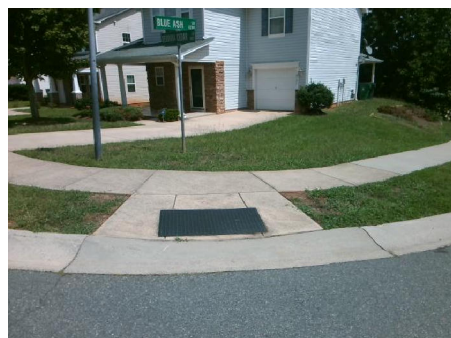
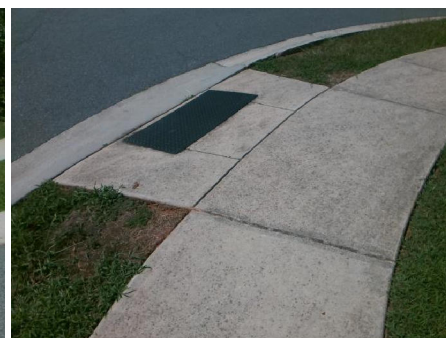
**Not Found, R304.5.1, R304.5.3**

Compliance	Description	Data	Compliance	Description	Data
N/A	Ramp Length (in)	48.0	Yes	Ramp Slope (%)	8.1
No	Ramp Width (in)	34.5	No	Ramp XSlope (%)	4.4
N/A	Flare Type LT	N/A	N/A	Flare Type RT	N/A
N/A	Flare Slope LT (%)	N/A	N/A	Flare Slope RT (%)	N/A
N/A	Flare Traversable LT?	N/A	N/A	Flare Traversable RT?	N/A
N/A	Landing Length (in)	N/A	N/A	DWS Provided?	N/A
N/A	Landing Width (in)	N/A	N/A	DWS Contrast?	N/A
N/A	Landing Slope (%)	N/A	N/A	DWS Length (in)	N/A
N/A	Landing X Slope (%)	N/A	N/A	DWS Full Width?	N/A
N/A	Landing Curb? (Y/N)	N/A	N/A	DWS Offset (in)	N/A
N/A	Shared Landing?	N/A			
N/A	Gutter Ponding?	N/A	N/A	Gutter Slope (%)	N/A
N/A	Gutter Lip Ht (in)	N/A	N/A	Gutter X Slope (%)	N/A
N/A	Painted X Walk1?	No	N/A	Painted X Walk2?	No
	X Walk 1 Direction	To NW		X Walk 2 Direction	To SW
N/A	X Walk 1 Width (in)	N/A	N/A	X Walk 2 Width (in)	N/A
	X Walk 1 Slope (%)	3.1		X Walk 2 Slope (%)	1.0
	X Walk 1 X Slope (%)	0.1		X Walk 2 X Slope (%)	5.6

N/A	Ramp inside XWalk1?	N/A	N/A	Ramp inside XWalk2?	N/A
	Road Slope (%)	6.7	N/A	Clear Space?	N/A
	Road X Slope (%)	3.3	N/A	Clear Space to XWalk (in)	N/A
N/A	Any Obstructions?	N/A	N/A	Storm Grate/Utility Hazard?	N/A
	Obstruction Type			Storm Grate/Utility Type	
		N/A			N/A
			Yes	Surface Condition? (G/P)	Good

**Remove & Replace Curb Ramp With Two New Directional Ramps or Equivalent.**
