# Access Compliance Report

## Public Rights-of-Way

### (Curb Ramps)

Intersection ID: 12739	Main Street: N_MCDOWELL_ST	Cross Street: E_8TH_ST	Location:	W
ADA ID: 1673C4353B01	Ramp Type: Combination2Diag	Initial Pass/Fail: Fail	Overall Compliance: No	Severity Score: 0

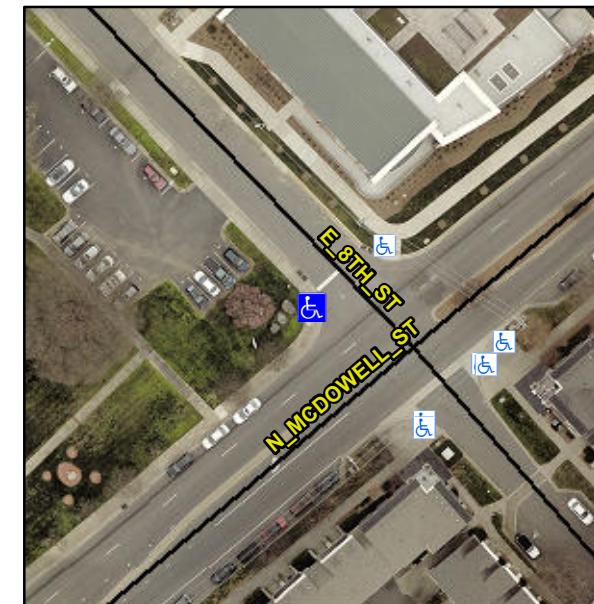
**Not Found, R304.5.3, R304.3.2**

Compliance	Description	Data	Compliance	Description	Data
N/A	Ramp Length LT (in)	N/A	N/A	Ramp Length RT (in)	53.0
N/A	Ramp Width LT (in)	N/A	Yes	Ramp Width RT (in)	51.0
N/A	Ramp Slope LT (%)	N/A	No	Ramp Slope RT (%)	9.3
N/A	Ramp XSlope LT (%)	N/A	No	Ramp XSlope RT (%)	2.6
N/A	Ramp Length (in)	25.0	Yes	Ramp Slope (%)	5.8
Yes	Ramp Width (in)	48.0	No	Ramp XSlope (%)	3.7
N/A	Flare Type LT	N/A	N/A	Flare Type RT	N/A
N/A	Flare Slope LT (%)	N/A	N/A	Flare Slope RT (%)	N/A
N/A	Flare Traversable LT?	N/A	N/A	Flare Traversable RT?	N/A
N/A	Landing Length (in)	N/A	N/A	DWS Provided?	N/A
N/A	Landing Width (in)	N/A	N/A	DWS Contrast?	N/A
N/A	Landing Slope (%)	N/A	N/A	DWS Length (in)	N/A
N/A	Landing X Slope (%)	N/A	N/A	DWS Full Width?	N/A
N/A	Landing Curb? (Y/N)	N/A	N/A	DWS Offset (in)	N/A
N/A	Shared Landing?	N/A			
N/A	Gutter Ponding?	N/A	N/A	Gutter Slope (%)	N/A
N/A	Gutter Lip Ht (in)	N/A	N/A	Gutter X Slope (%)	N/A
N/A	Painted X Walk1?	No	N/A	Painted X Walk2?	No

X Walk 1 Direction	To SE		X Walk 2 Direction	To NE
	X Walk 1 Width (in)	N/A		X Walk 2 Width (in)	N/A
	X Walk 1 Slope (%)	2.2		X Walk 2 Slope (%)	0.8
	X Walk 1 X Slope (%)	0.8		X Walk 2 X Slope (%)	2.2
N/A	Ramp inside XWalk1?	N/A	N/A	Ramp inside XWalk2?	N/A
	Road Slope (%)	4.3		Clear Space?	N/A
	Road X Slope (%)	0.3	N/A	Clear Space to XWalk (in)	N/A
			N/A	Any Obstruction?	N/A
				Obstruction Type	N/A
			N/A	Storm Grate/Utility Hazard?	N/A
				Storm Grate/Utility Type	N/A
			Yes	Surface Condition? (G/P)	Good
				Curb Slope (%)	24.9

**Remove & Replace Curb Ramp With Two New Directional Ramps or Equivalent.**
