# Access Compliance Report

## Public Rights-of-Way

### (Curb Ramps)

| Intersection ID: 25405 | Main Street: MARMOT_POINT_LN | Cross Street: PROVIDENCE_PLANTATION_LN | Location: NW |

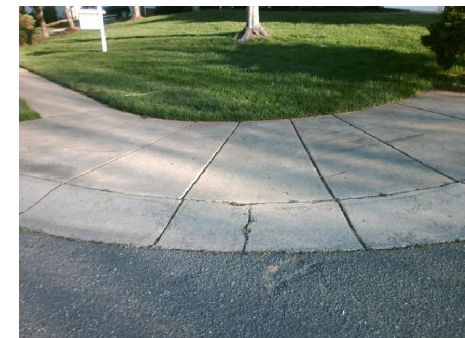
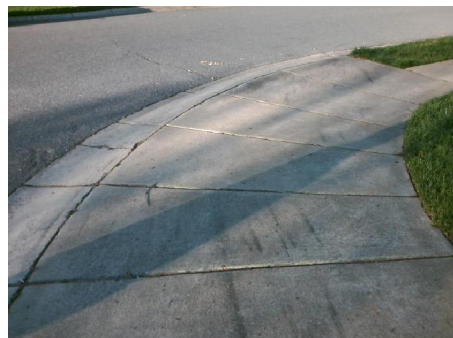
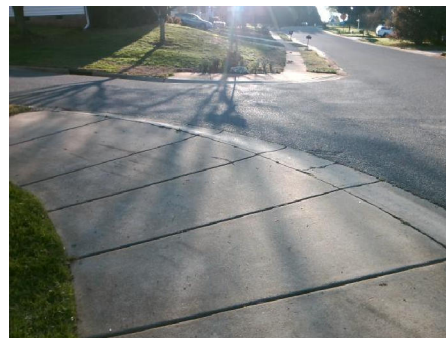
| ADA ID: 168D562C6C04 | Ramp Type: BlendTrans1 | Initial Pass/Fail: Fail | Overall Compliance: No |

**Not Found, R304.5.1, R304.5.3**

| Compliance | Description | Data | Compliance | Description | Data |
|---|---|---|---|---|---|
| No | Ramp Width (in) | 29.0 | No | BlendTrans XSlope (%) | 6.9 |

**Remove & Replace Curb Ramp With Two New Directional Ramps or Equivalent.**
