Access Compliance Report

Public Rights-of-Way

(Curb Ramps)

Intersection ID: 2555	Main Street: PELORUS_LN	Cross Street: TARBY_CT	Location:	W
ADA ID: 169BF20FB901	Ramp Type: PerpDiag	Initial Pass/Fail: Fail	Overall Compliance: No	Severity Score: 25
Codes/Mitigation Info/Possible Solution		Field Measurements/Component Compliance

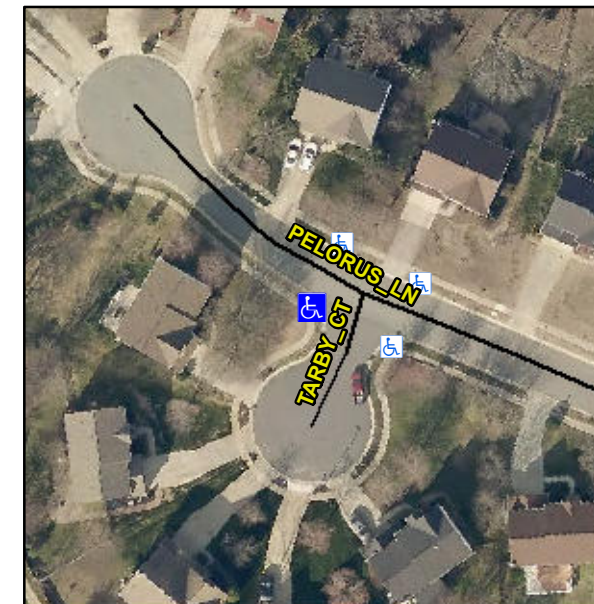
Not Found, R304.2.2, R304.5.3

Compliance	Description	Data	Compliance	Description	Data
N/A	Ramp Length (in)	38.0	No	Ramp Slope (%)	8.4
Yes	Ramp Width (in)	48.0	No	Ramp XSlope (%)	5.5
N/A	Flare Type LT	N/A	N/A	Flare Type RT	N/A
N/A	Flare Slope LT (%)	N/A	N/A	Flare Slope RT (%)	N/A
N/A	Flare Traversable LT?	N/A	N/A	Flare Traversable RT?	N/A
N/A	Landing Length (in)	N/A	N/A	DWS Provided?	N/A
N/A	Landing Width (in)	N/A	N/A	DWS Contrast?	N/A
N/A	Landing Slope (%)	N/A	N/A	DWS Length (in)	N/A
N/A	Landing X Slope (%)	N/A	N/A	DWS Full Width?	N/A
N/A	Landing Curb? (Y/N)	N/A	N/A	DWS Offset (in)	N/A
N/A	Shared Landing?	N/A			
N/A	Gutter Ponding?	N/A	N/A	Gutter Slope (%)	N/A
N/A	Gutter Lip Ht (in)	1.0	N/A	Gutter X Slope (%)	N/A
N/A	Painted X Walk1?	No	N/A	Painted X Walk2?	No
	X Walk 1 Direction	To SE		X Walk 2 Direction	To NE
N/A	X Walk 1 Width (in)	N/A	N/A	X Walk 2 Width (in)	N/A
	X Walk 1 Slope (%)	0.4		X Walk 2 Slope (%)	2.8
	X Walk 1 X Slope (%)	1.8		X Walk 2 X Slope (%)	2.7

N/A	Ramp inside XWalk1?	N/A	N/A	Ramp inside XWalk2?	N/A
	Road Slope (%)	6.1	N/A	Clear Space?	N/A
	Road X Slope (%)	4.0	N/A	Clear Space to XWalk (in)	N/A
N/A	Any Obstructions?	N/A	N/A	Storm Grate/Utility Hazard?	N/A
	Obstruction Type			Storm Grate/Utility Type	
		N/A			N/A
		Yes		Surface Condition? (G/P)	Good

Remove & Replace Curb Ramp With Two New Directional Ramps or Equivalent.
