# Access Compliance Report

### (Curb Ramps)

| Intersection ID: 22384 | Main Street: PARK_RD | Cross Street: HENNESSY_PL | Location: NW |
| ADA ID: 17146D52AFD3 | Ramp Type: Combination1Diag | Initial Pass/Fail: Fail | Overall Compliance: No |

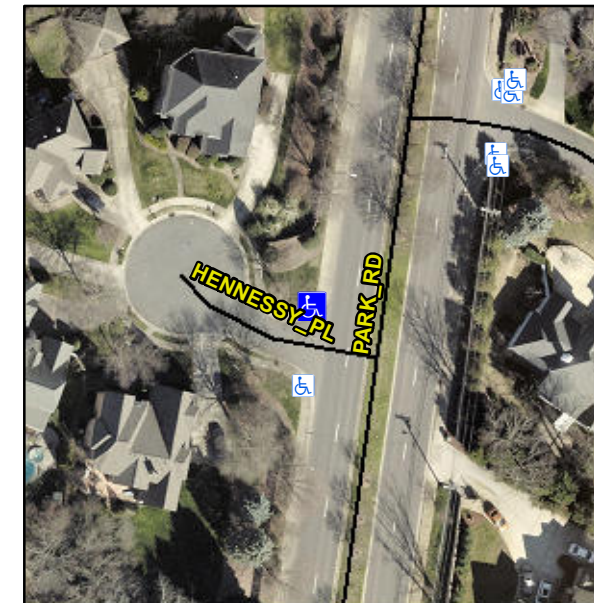
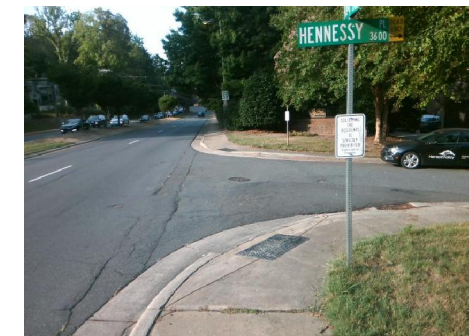
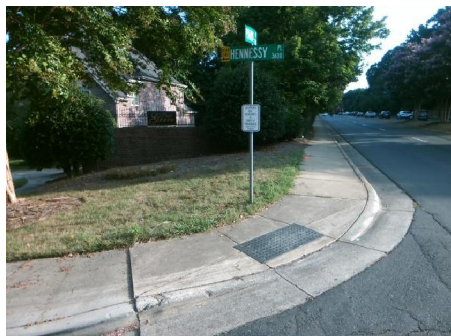
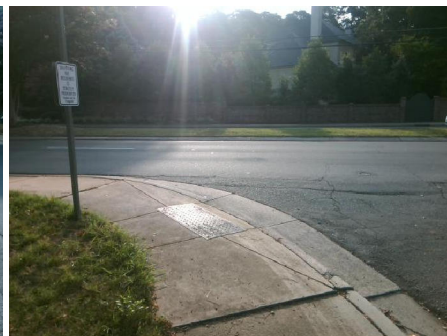
**CURB LIP 1.0**

**R304.5.1, R304.2.2, R304.5.3, R304.3.2**

| Compliance | Description | Data | Compliance | Description | Data |
|---|---|---|---|---|---|
| No | Ramp Width LT (in) | 37.0 | No | Ramp Width RT (in) | 37.0 |
| Yes | Ramp Slope LT (%) | 6.8 | No | Ramp Slope RT (%) | 11.1 |
| N/A | Ramp Length (in) | 24.0 | No | Ramp Slope (%) | 8.8 |
| Yes | Ramp Width (in) | 48.0 | No | Ramp XSlope (%) | 8.3 |

**Remove & Replace Curb Ramp With Two New Directional Ramps or Equivalent.**
