Access Compliance Report Public Rights-of-Way (Curb Ramps)

Intersection ID: 7023 Main Street: EASTER_LN Cross Street: MELYNDA_RD Location: **Overall Compliance: No Severity Score:** ADA ID: 174A6F0FF574 Ramp Type: Perp Initial Pass/Fail: Fail 12.5

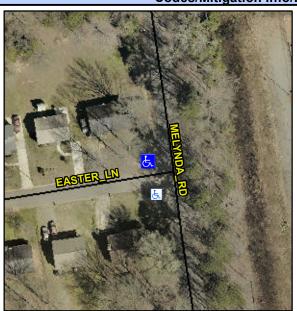
Field Measurements/Component Compliance						
Comp	liance Description	Data	Comp	liance	Description	Data
N/A	Ramp Length (in)	48.0	No	Ramp	Slope (%)	8.6
Yes	Ramp Width (in)	48.0	Yes	Ramp	XSlope (%)	1.3
N/A	Flare Type LT	N/A	N/A	Flare	Type RT	N/A
N/A	Flare Slope LT (%)	N/A	N/A	Flare	Slope RT (%)	N/A
N/A	Flare Traversable LT?	N/A	N/A	Flare	Traversable RT?	N/A
N/A	Landing Length (in)	N/A	N/A	DWS	Provided?	N/A
N/A	Landing Width (in)	N/A	N/A	DWS	Contrast?	N/A
N/A	Landing Slope (%)	N/A	N/A	DWS	Length (in)	N/A
N/A	Landing X Slope (%)	N/A	N/A	DWS	Full Width?	N/A
N/A	Landing Curb? (Y/N)	N/A	N/A	DWS	Offset (in)	N/A
N/A	Shared Landing?	N/A				
N/A	Gutter Ponding?	N/A	N/A	Gutte	er Slope (%)	N/A
N/A	Gutter Lip Ht (in)	N/A	N/A	Gutte	er X Slope (%)	N/A
N/A	Painted X Walk1?	No	N/A	Paint	ed X Walk2?	N/A
	X Walk 1 Direction	To S		X Wa	lk 2 Direction	N/A
N/A	X Walk 1 Width (in)	N/A	N/A	X Wa	lk 2 Width (in)	N/A
	X Walk 1 Slope (%)	1.1		X Wa	lk 2 Slope (%)	N/A

Possible Solutions:	Col
Remove & Replace Entire Ramp.	N/A
	Yes
	N/A
	N/A
	N/A
	N/A
Surveyor Notes:	N/A
N/A	N/A
	N/A
	N/A
	N/A
PROW/ADA:	N/A
Not Found, R304.2.2	N/A
,	N/A
	N/A
	N/A
