## **Access Compliance Report Public Rights-of-Way** (Curb Ramps)

Intersection ID: 25067 Main Street: CARRIAGE LAKE DR **Cross Street: SMITH RD** Location: NE ADA ID: 178C4E50685C Ramp Type: BlendTrans2 Initial Pass/Fail: Pass **Overall Compliance: No Severity Score:** 2.75

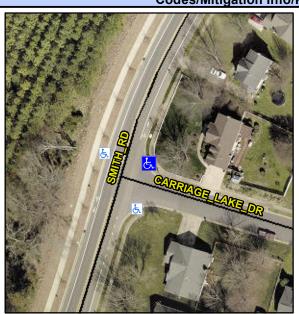
Field Measurements/Component Compliance						
Compliance Description			Data	Compliance Description		Data
ı	N/A	Ramp Length (in)	96.0	Yes	BlendTrans Slope (%)	0.5
,	<b>Yes</b>	Ramp Width (in)	48.0	No	BlendTrans XSlope (%)	2.3
ı	N/A	Flare Type LT	None	N/A	Flare Type RT	None
ı	N/A	Flare Slope LT (%)	N/A	N/A	Flare Slope RT (%)	N/A
ı	N/A	Flare Traversable LT?	N/A	N/A	Flare Traversable RT?	N/A
ı	N/A	Landing Length (in)	N/A	Yes	DWS Provided?	Yes
ı	N/A	Landing Width (in)	N/A	Yes	DWS Contrast?	Yes
ı	N/A	Landing Slope (%)	N/A	Yes	DWS Length (in)	24.0
ı	N/A	Landing X Slope (%)	N/A	No	DWS Full Width?	No
ı	N/A	Landing Curb? (Y/N)	No	No	DWS Offset (in)	5.0
ı	N/A	Shared Landing?	No			
,	<b>Yes</b>	Gutter Ponding?	No	Yes	Gutter Slope (%)	3.8
`	es/	Gutter Lip Ht (in)	0.0	No	Gutter X Slope (%)	2.5
ı	N/A	Painted X Walk1?	No	N/A	Painted X Walk2?	No
		X Walk 1 Direction	To NW		X Walk 2 Direction	To SW
		X Walk 1 Width (in)	N/A		X Walk 2 Width (in)	N/A

X Walk 1 Slope (%)	0.9		X Walk 2 Slope (%)	1.9
		X Walk 1 X Slope (%)	0.7		X Walk 2 X Slope (%)	0.7
ı	N/A	Ramp inside XWalk1?	N/A	N/A	Ramp inside XWalk2?	N/A
		Road Slope (%)	2.9		Clear Space?	Yes
		Road X Slope (%)	1.6	N/A	Clear Space to XWalk (in)	N/A
,	<b>Yes</b>	Any Obstructions?	No	Yes	Storm Grate/Utility Hazard?	No
		Obstruction Type			Storm Grate/Utility Type	
			N/A			N/A
				Yes	Surface Condition? (G/P)	Good
	No.			No	Curb Slope (%)	30.8

Possible Solutions: Remove & Replace Curb Ramp With Two New Directional Ramps or Equivalent. Remove & Replace Gutter. Surveyor Notes: N/A PROW/ADA: Not Found, R304.5.3, R305.1.4, R305.2
