Access Compliance Report Public Rights-of-Way (Curb Ramps)

Intersection ID: 44918 Main Street: PALUSTRIS_CT Cross Street: MAPLE_PARK_LN Location: SW

ADA ID: 17B3AD6A02D8 Ramp Type: PerpDiag Initial Pass/Fail: Fail Overall Compliance: No Severity Score: 46.25

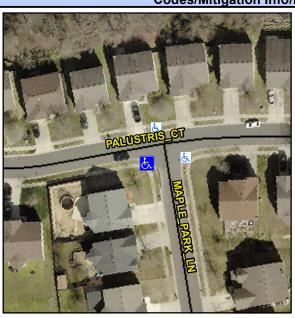
Not Found, R304.5.1, R304.2.2, R304.5.3

| Field Measurements/Component Compilance | | | | | |
|---|---|---|---|---|---|
| N/A | Ramp Length (in) | 46.5 | No | Ramp Slope (%) | 16.7 |
| No | Ramp Width (in) | 37.5 | No | Ramp XSlope (%) | 6.6 |

Remove & Replace Curb Ramp With Two New Directional Ramps or Equivalent.
