# Access Compliance Report

## Public Rights-of-Way

### (Curb Ramps)

| Intersection ID: 15236 | Main Street: CARLING_AV | Cross Street: DILWORTH_RD_EAST | Location: E |

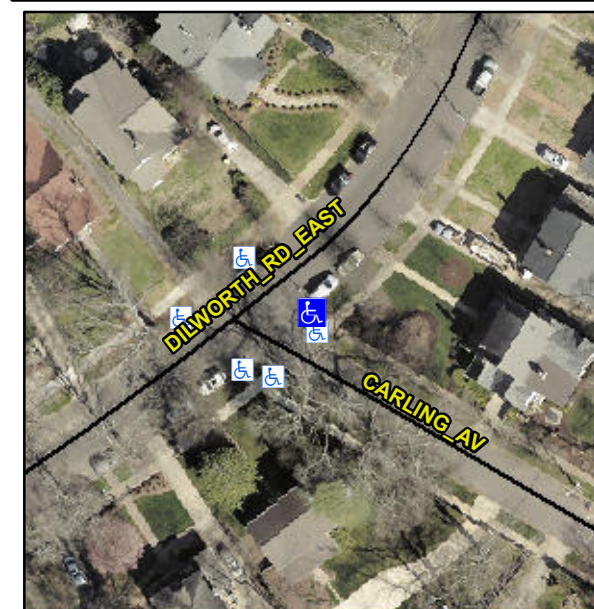
| ADA ID: 17B788A543FA | Ramp Type: Perp | Initial Pass/Fail: Pass | Overall Compliance: No |

**R304.5.3, R305, R302.7.2, R304.5.4**

| Compliance | Description | Data | Compliance | Description | Data |
|---|---|---|---|---|---|
| Yes | Landing Length (in) | 50.0 | No | DWS Provided? | No |
| No | Landing X Slope (%) | 2.7 | N/A | DWS Full Width? | No |
| Yes | Gutter Ponding? | No | No | Gutter Slope (%) | 7.9 |
| No | Gutter Lip Ht (in) | 1.0 | Yes | Gutter X Slope (%) | 0.6 |

**Remove & Replace Entire Ramp.  
Remove & Replace Gutter.**
