# Access Compliance Report

## Public Rights-of-Way

| Intersection ID: 43663 | Main Street: TAYLOR RIDGE LN | Cross Street: HUNTINGTON MEADOW LN | Location: SW |
| ADA ID: 18B378556429 | Ramp Type: Combination1 | Initial Pass/Fail: Fail | Overall Compliance: No |

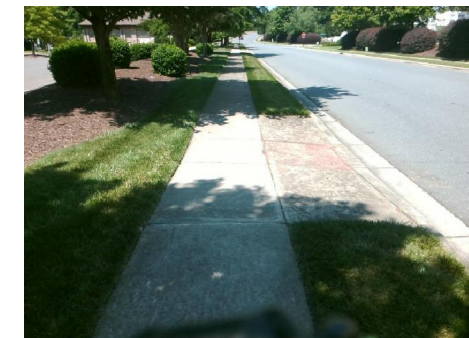
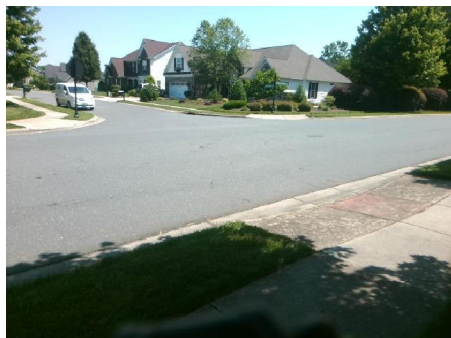
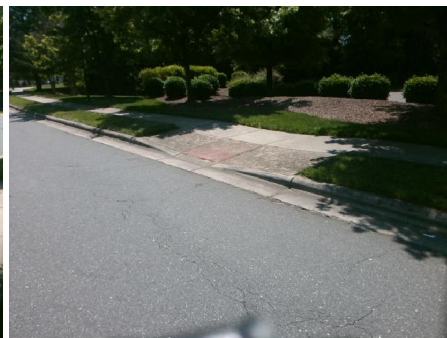
**RT RP < 5%**

**R304.5.1, R304.2.2, R304.5.3**

| Compliance | Description | Data | Compliance | Description | Data |
|---|---|---|---|---|---|
| Yes | Ramp XSlope LT (%) | 2.0 | No | Ramp XSlope RT (%) | 2.9 |
| N/A | Ramp Length (in) | 47.0 | No | Ramp Slope (%) | 9.2 |
| No | Ramp Width (in) | 47.0 | No | Ramp XSlope (%) | 2.8 |

**Remove & Replace Entire Ramp.**
