# Access Compliance Report

## Public Rights-of-Way

### (Curb Ramps)

Intersection ID: 45517	Main Street: BUGGY_HORSE_RD	Cross Street: MEADOW_BOTTOM_RD	Location: S
ADA ID: 18FDD3B7EB43	Ramp Type: PerpDiag	Initial Pass/Fail: Fail	Overall Compliance: No
Severity Score: 42.5			
Codes/Mitigation Info/Possible Solution		Field Measurements/Component Compliance

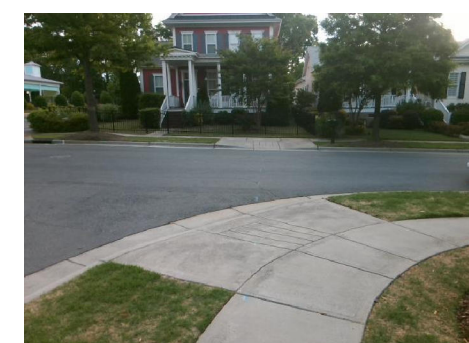
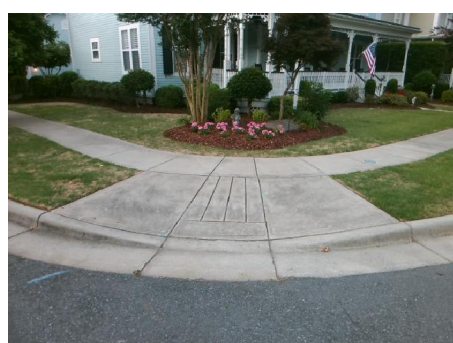
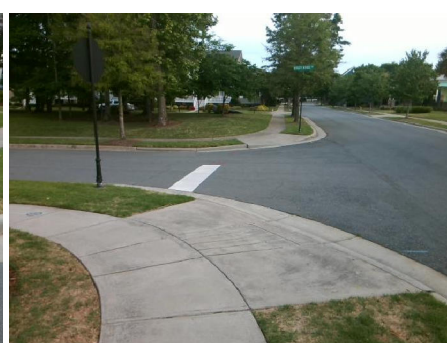
**Not Found, R304.5.1, R304.2.2**

Compliance	Description	Data	Compliance	Description	Data
N/A	Ramp Length (in)	73.0	No	Ramp Slope (%)	12.4
No	Ramp Width (in)	32.0	Yes	Ramp XSlope (%)	0.9
N/A	Flare Type LT	N/A	N/A	Flare Type RT	N/A
N/A	Flare Slope LT (%)	N/A	N/A	Flare Slope RT (%)	N/A
N/A	Flare Traversable LT?	N/A	N/A	Flare Traversable RT?	N/A
N/A	Landing Length (in)	N/A	N/A	DWS Provided?	N/A
N/A	Landing Width (in)	N/A	N/A	DWS Contrast?	N/A
N/A	Landing Slope (%)	N/A	N/A	DWS Length (in)	N/A
N/A	Landing X Slope (%)	N/A	N/A	DWS Full Width?	N/A
N/A	Landing Curb? (Y/N)	N/A	N/A	DWS Offset (in)	N/A
N/A	Shared Landing?	N/A			
N/A	Gutter Ponding?	N/A	N/A	Gutter Slope (%)	N/A
N/A	Gutter Lip Ht (in)	N/A	N/A	Gutter X Slope (%)	N/A
N/A	Painted X Walk1?	No	N/A	Painted X Walk2?	No
	X Walk 1 Direction	To NE		X Walk 2 Direction	To NW
N/A	X Walk 1 Width (in)	N/A	N/A	X Walk 2 Width (in)	N/A
	X Walk 1 Slope (%)	6.6		X Walk 2 Slope (%)	5.4
	X Walk 1 X Slope (%)	2.5		X Walk 2 X Slope (%)	3.4

**Remove & Replace Curb Ramp With Two New Directional Ramps or Equivalent.**
