# Access Compliance Report

## Public Rights-of-Way

| Intersection ID: 42950 | Main Street: BENZIGER_CT | Cross Street: LONG_PAW_LN | Location: NE |
| ADA ID: 19019A22B57D | Ramp Type: PerpDiag | Initial Pass/Fail: Fail | Overall Compliance: No |

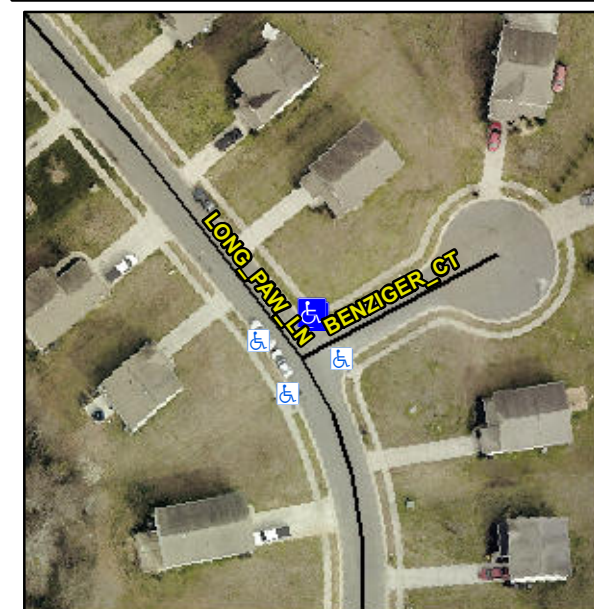
| Severity Score: 8.75 | | | |

**Not Found, R304.5.1**

| Compliance | Description | Data | Compliance | Description | Data |
|---|---|---|---|---|---|
| No | Ramp Width (in) | 47.0 | Yes | Ramp XSlope (%) | 0.6 |

**Remove & Replace Curb Ramp With Two New Directional Ramps or Equivalent.**

Total Cost: \$ 3200.00

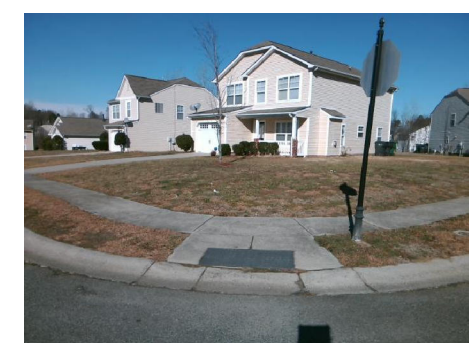
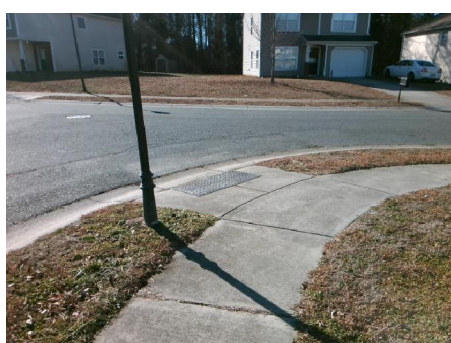
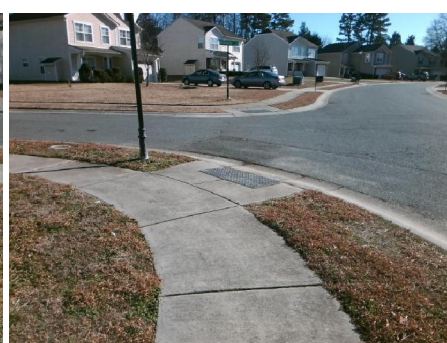
| Compliance | Description | Data | Compliance | Description | Data |
|---|---|---|---|---|---|
| | | Yes | | Surface Condition? (G/P) | Good |
