Access Compliance Report Public Rights-of-Way (Curb Ramps)

Intersection ID: 3120Main Street:DAUPHINE_DRCross Street:WALDEN_RIDGE_DRLocation:EADA ID: 1962D01DFDDFRamp Type:PerpInitial Pass/Fail:FailOverall Compliance:NoSeverity Score:22.5

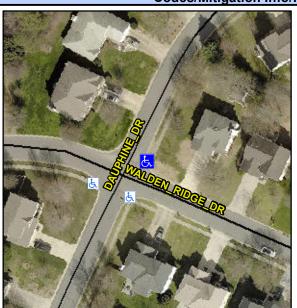
i ossible odlation	
Possible Solutions:	
Remove & Replace Entire Ramp.	
	ı
	N
	1
	1
	1
Surveyor Notes:	1
N/A	N
	1
	N
	N
PROW/ADA:	N
Not Found, R304.5.1, R304.2.2,	N
R304.5.3	N
	N

Field Measurements/Component Compliance							
Compli	ance Description	Data	Comp	liance Description	Data		
N/A	Ramp Length (in)	29.0	No	Ramp Slope (%)	10.3		
No	Ramp Width (in)	46.0	No	Ramp XSlope (%)	4.5		
N/A	Flare Type LT	N/A	N/A	Flare Type RT	N/A		
N/A	Flare Slope LT (%)	N/A	N/A	Flare Slope RT (%)	N/A		
N/A	Flare Traversable LT?	N/A	N/A	Flare Traversable RT?	N/A		
N/A	Landing Length (in)	N/A	N/A	DWS Provided?	N/A		
N/A	Landing Width (in)	N/A	N/A	DWS Contrast?	N/A		
N/A	Landing Slope (%)	N/A	N/A	DWS Length (in)	N/A		
N/A	Landing X Slope (%)	N/A	N/A	DWS Full Width?	N/A		
N/A	Landing Curb? (Y/N)	N/A	N/A	DWS Offset (in)	N/A		
N/A	Shared Landing?	N/A					
N/A	Gutter Ponding?	N/A	N/A	Gutter Slope (%)	N/A		
N/A	Gutter Lip Ht (in)	N/A	N/A	Gutter X Slope (%)	N/A		
N/A	Painted X Walk1?	No	N/A	Painted X Walk2?	N/A		
	X Walk 1 Direction	To SW		X Walk 2 Direction	N/A		
N/A	X Walk 1 Width (in)	N/A	N/A	X Walk 2 Width (in)	N/A
