# Access Compliance Report

## Public Rights-of-Way

### (Curb Ramps)

Intersection ID: 14312	Main Street: W_TYVOLA_RD	Cross Street: SHADY_LN	Location: S
ADA ID: 1A4E39AAFCA9	Ramp Type: Combination1	Initial Pass/Fail: Fail	Overall Compliance: No
		Severity Score: 22.5

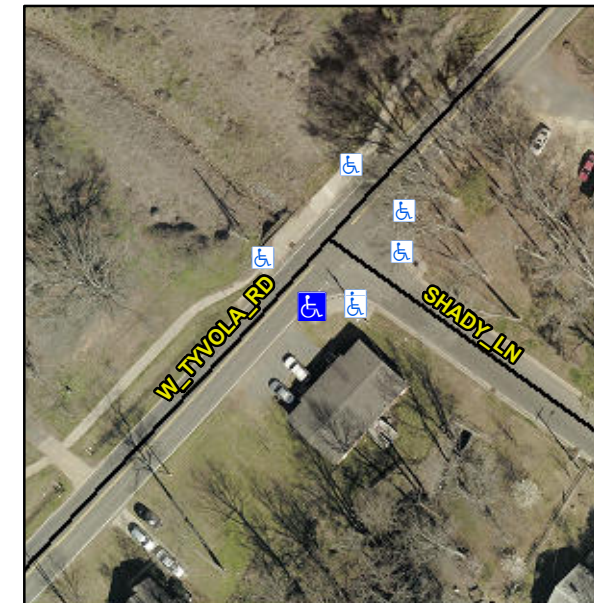
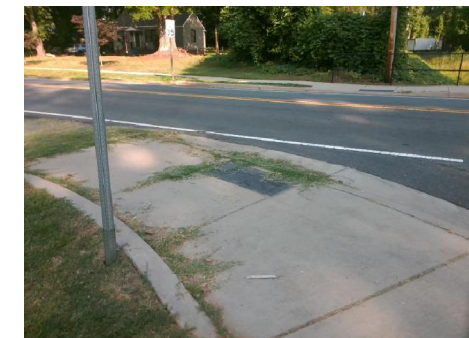
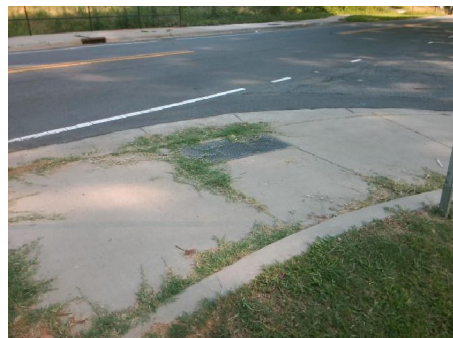
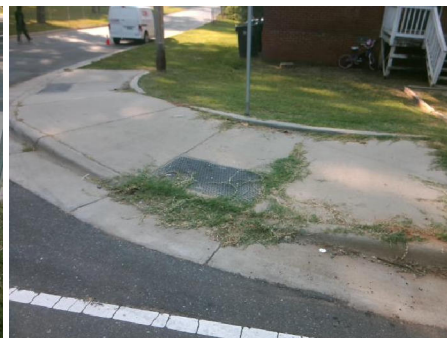
**LT RP < 5%**

**R304.5.1, R304.5.3, R304.3.2**

Compliance	Description	Data	Compliance	Description	Data
N/A	Ramp Length LT (in)	48.0	N/A	Ramp Length RT (in)	61.0
Yes	Ramp Width LT (in)	84.0	Yes	Ramp Width RT (in)	85.0
Yes	Ramp Slope LT (%)	1.0	No	Ramp Slope RT (%)	11.1
Yes	Ramp XSlope LT (%)	1.1	Yes	Ramp XSlope RT (%)	1.4
N/A	Ramp Length (in)	83.0	Yes	Ramp Slope (%)	3.0
No	Ramp Width (in)	45.0	No	Ramp XSlope (%)	2.3
N/A	Flare Type LT	N/A	N/A	Flare Type RT	N/A
N/A	Flare Slope LT (%)	N/A	N/A	Flare Slope RT (%)	N/A
N/A	Flare Traversable LT?	N/A	N/A	Flare Traversable RT?	N/A
N/A	Landing Length (in)	N/A	N/A	DWS Provided?	N/A
N/A	Landing Width (in)	N/A	N/A	DWS Contrast?	N/A
N/A	Landing Slope (%)	N/A	N/A	DWS Length (in)	N/A
N/A	Landing X Slope (%)	N/A	N/A	DWS Full Width?	N/A
N/A	Landing Curb? (Y/N)	N/A	N/A	DWS Offset (in)	N/A
N/A	Shared Landing?	N/A			
N/A	Gutter Ponding?	N/A	N/A	Gutter Slope (%)	N/A
N/A	Gutter Lip Ht (in)	N/A	N/A	Gutter X Slope (%)	N/A
N/A	Painted X Walk1?	No	N/A	Painted X Walk2?	N/A

**Remove & Replace Entire Ramp.**

Total Cost: \$ 1800.00
