# Access Compliance Report

## Public Rights-of-Way

### (Curb Ramps)

| Intersection ID: 21411 | Main Street: MONROE_RD | Cross Street: SARDIS_RD_NORTH | Location: NW |

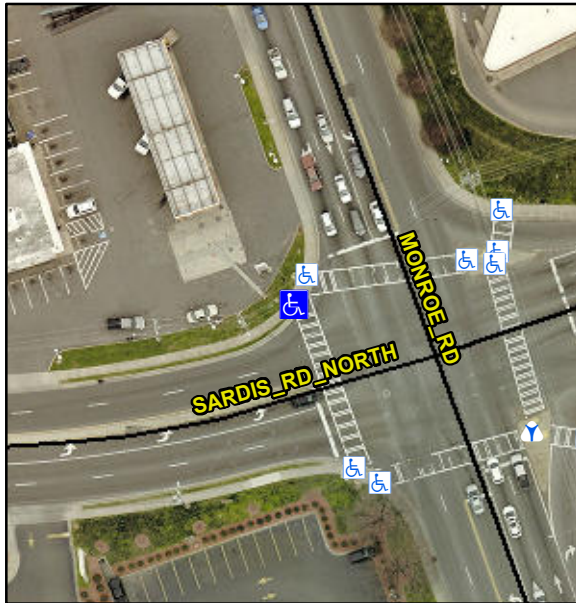
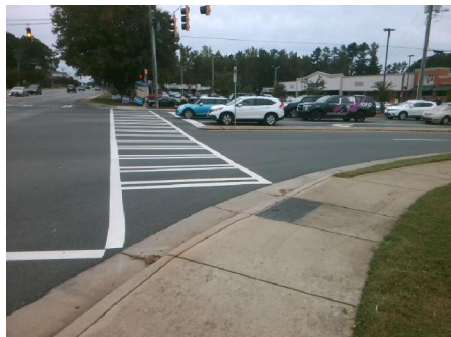
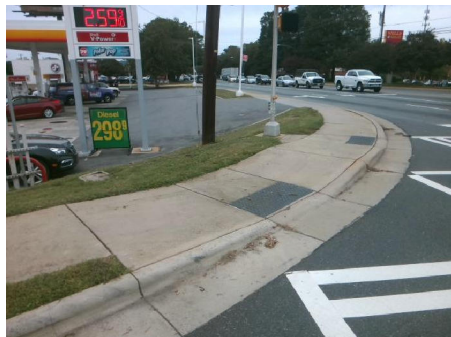
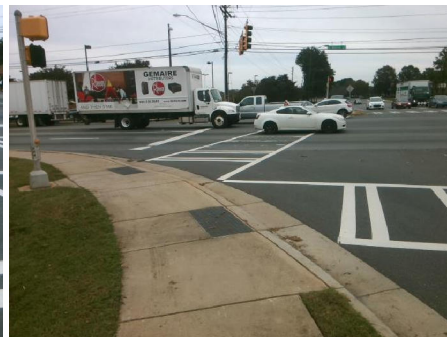
| ADA ID: 1AC346BA0BAE | Ramp Type: Para | Initial Pass/Fail: Fail | Overall Compliance: No |
| | | Severity Score: 12.5 | |

**R304.3.2**

| Compliance | Description | Data | Compliance | Description | Data |
|---|---|---|---|---|---|
| No | Ramp Slope LT (%) | 8.5 | Yes | Ramp Slope RT (%) | 5.2 |

**Remove & Replace Entire Ramp.**
