# Access Compliance Report

## Public Rights-of-Way

### (Curb Ramps)

Intersection ID: 26242	Main Street: BAYBROOK_LN	Cross Street: BEVINGTON_PL	Location: SE
ADA ID: 1AFBAF86BB87	Ramp Type: PerpDiag	Initial Pass/Fail: Fail	Overall Compliance: No
Severity Score: 13.75			
Codes/Mitigation Info/Possible Solution		Field Measurements/Component Compliance

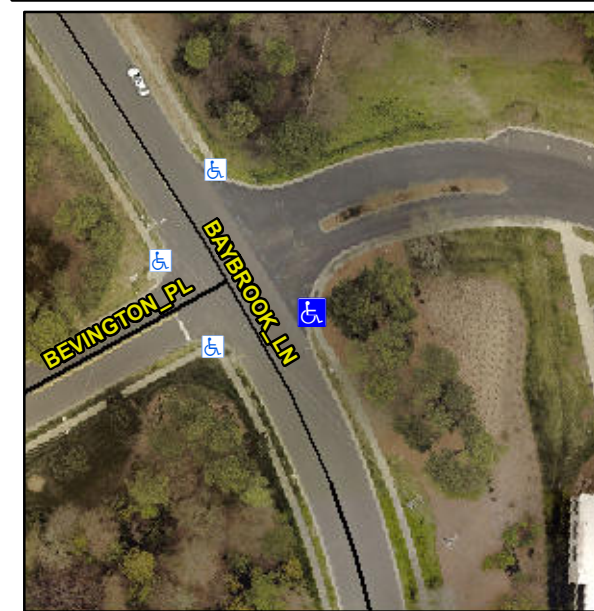
**Not Found, R304.2.2, R304.5.3**

Compliance	Description	Data	Compliance	Description	Data
N/A	Ramp Length (in)	47.5	No	Ramp Slope (%)	9.8
Yes	Ramp Width (in)	48.0	No	Ramp XSlope (%)	3.8
N/A	Flare Type LT	N/A	N/A	Flare Type RT	N/A
N/A	Flare Slope LT (%)	N/A	N/A	Flare Slope RT (%)	N/A
N/A	Flare Traversable LT?	N/A	N/A	Flare Traversable RT?	N/A
N/A	Landing Length (in)	N/A	N/A	DWS Provided?	N/A
N/A	Landing Width (in)	N/A	N/A	DWS Contrast?	N/A
N/A	Landing Slope (%)	N/A	N/A	DWS Length (in)	N/A
N/A	Landing X Slope (%)	N/A	N/A	DWS Full Width?	N/A
N/A	Landing Curb? (Y/N)	N/A	N/A	DWS Offset (in)	N/A
N/A	Shared Landing?	N/A			
N/A	Gutter Ponding?	N/A	N/A	Gutter Slope (%)	N/A
N/A	Gutter Lip Ht (in)	N/A	N/A	Gutter X Slope (%)	N/A
N/A	Painted X Walk1?	No	N/A	Painted X Walk2?	No
	X Walk 1 Direction	To NW		X Walk 2 Direction	To W
N/A	X Walk 1 Width (in)	N/A	N/A	X Walk 2 Width (in)	N/A
	X Walk 1 Slope (%)	5.7		X Walk 2 Slope (%)	1.2
	X Walk 1 X Slope (%)	0.0		X Walk 2 X Slope (%)	5.2

N/A	Ramp inside XWalk1?	N/A	N/A	Ramp inside XWalk2?	N/A
	Road Slope (%)	0.8	N/A	Clear Space?	N/A
	Road X Slope (%)	5.7	N/A	Clear Space to XWalk (in)	N/A
N/A	Any Obstructions?	N/A	N/A	Storm Grate/Utility Hazard?	N/A
	Obstruction Type			Storm Grate/Utility Type	
		N/A			N/A
		Yes		Surface Condition? (G/P)	Good

**Remove & Replace Curb Ramp With Two New Directional Ramps or Equivalent.**

Total Cost: \$ 3200.00
