# Access Compliance Report

## Public Rights-of-Way

### (Curb Ramps)

| Intersection ID: 3047 | Main Street: BUCK_CT | Cross Street: WHITE_STAG_DR | Location: NW |

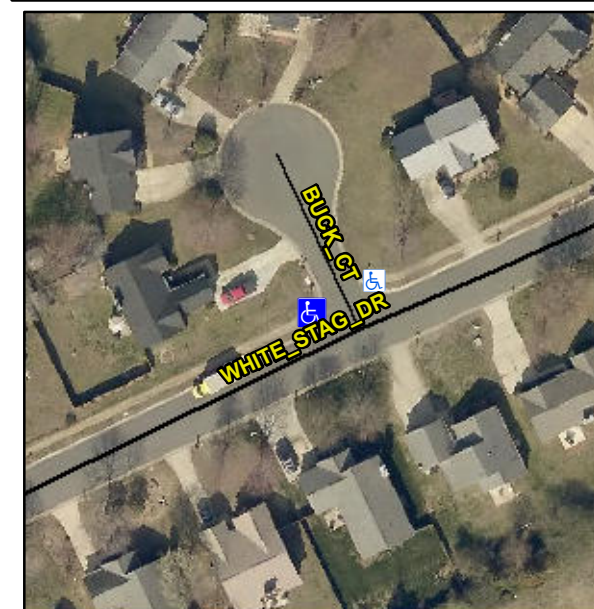
| ADA ID: 1B0A5E2936AB | Ramp Type: Perp | Initial Pass/Fail: Fail | Overall Compliance: No |
| Severity Score: 22.5 | | | |

**Not Found, R304.5.1, R304.2.2, R304.5.3**

| Compliance | Description | Data | Compliance | Description | Data |
|---|---|---|---|---|---|
| N/A | Ramp Length (in) | 47.0 | No | Ramp Slope (%) | 9.2 |
| No | Ramp Width (in) | 37.0 | No | Ramp XSlope (%) | 3.4 |

**Remove & Replace Entire Ramp.**
